# Access Compliance Report

## Public Rights-of-Way

### (Island Curb Cuts)

Intersection ID: 6640	Main Street: ARVIN_DR	Cross Street: COCHRANE_DR	Location:	N
ADA ID: 0739B0B4FA27	Curb Cut Type: MedianRefuge2	Initial Pass/Fail: Pass	Overall Compliance: No	Severity Score: 25.25
Codes/Mitigation Info/Possible Solution		Field Measurements/Component Compliance

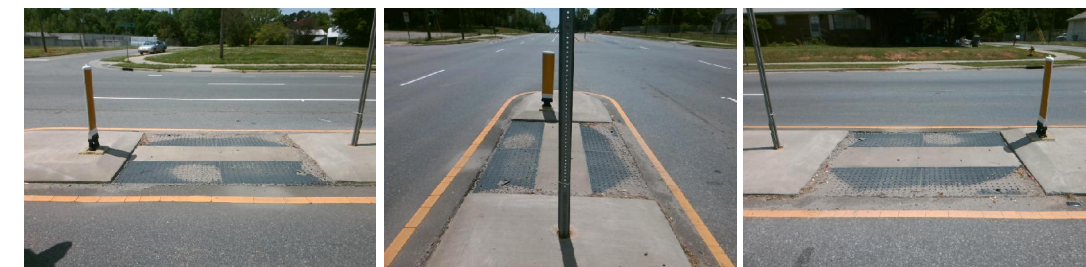
Compliance	Description	Data	Compliance	Description	Data
Yes	Refuge 1 Length (In)	36.5	No	Gutter 1 Ponding?	Yes
Yes	Refuge 1 Width (In)	95.0	No	Gutter 1 Lip Ht (In)	1.0
Yes	Refuge 1 Slope (%)	0.7	Yes	Gutter 1 Slope (%)	0.6
Yes	Refuge 1 X Slope (%)	0.3	Yes	Gutter 1 X Slope (%)	1.4
N/A	Painted X Walk1?	No	Yes	DWS 1 Provided?	Yes
N/A	X Walk 1 Direction	To E	Yes	DWS 1 Contrast?	Yes
N/A	X Walk 1 Width (In)	N/A	Yes	DWS 1 Length (In)	24.0
N/A	Road 1 Slope (%)	1.3	Yes	DWS 1 Full Width?	Yes
N/A	Road 1 X Slope (%)	0.1	Yes	DWS 1 Offset (In)	0.0
Yes	Refuge 2 Length (In)	36.5	No	Gutter 2 Ponding?	Yes
Yes	Refuge 2 Width (In)	95.0	No	Gutter 2 Lip Ht (In)	0.25
Yes	Refuge 2 Slope (%)	4.0	No	Gutter 2 Slope (%)	8.2
Yes	Refuge 2 X Slope (%)	0.8	Yes	Gutter 2 X Slope (%)	0.8
N/A	Painted X Walk2?	No	Yes	DWS 2 Provided?	Yes
N/A	X Walk 2 Direction	To W	Yes	DWS 2 Contrast?	Yes
N/A	X Walk 2 Width (In)	N/A	Yes	DWS 2 Length (In)	24.0

N/A	Road 2 Slope (%)	0.7	Yes	DWS 2 Full Width?	Yes
N/A	Road 2 X Slope (%)	2.3	Yes	DWS 2 Offset (In)	0.0
N/A	Refuge 3 Length (in)	N/A	N/A	Gutter 3 Ponding?	No
N/A	Refuge 3 Width (in)	N/A	N/A	Gutter 3 Lip Ht (in)	N/A
N/A	Refuge 3 Slope (%)	N/A	N/A	Gutter 3 Slope (%)	N/A
N/A	Refuge 3 XSlope (%)	N/A	N/A	Gutter 3 XSlope (%)	N/A
N/A	Painted X Walk3?	No	N/A	DWS 3 Provided?	N/A
N/A	X Walk 3 Direction	N/A	N/A	DWS 3 Contrast?	N/A
N/A	X Walk 3 Width (in)	N/A	N/A	DWS 3 Length (in)	N/A
N/A	Road 3 Slope (%)	N/A	N/A	DWS 3 Full Width?	N/A
N/A	Road 3 XSlope (%)	N/A	N/A	DWS 3 Offset (in)	N/A
Yes	Any Obstructions?	No	N/A	Storm Grate/Utility Hazard?	No
N/A	Obstruction Type		N/A	Storm Grate/Utility Type	
		N/A			N/A
N/A	Surface Condition	Good

**Grind Gutter Lip. Remove & Replace Gutter.**
