Access Compliance Report

Public Rights-of-Way

(Island Curb Cuts)

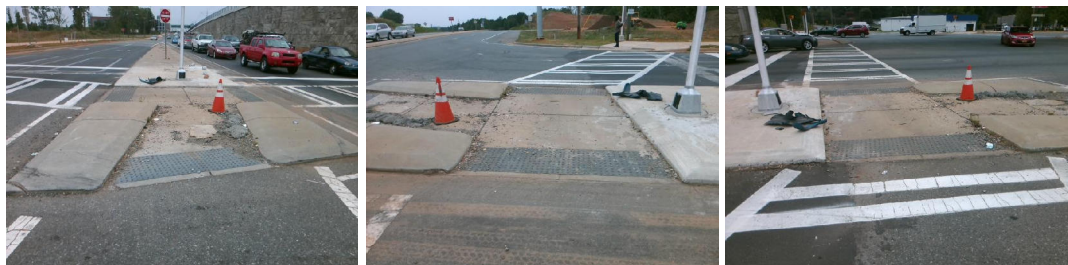
Intersection ID: 6957	Main Street: N_TRYON_ST	Cross Street: N_US_29_BY-PASS_HY	Location: NW
ADA ID: 075E2DBF994B	Curb Cut Type: IslandRefuge3	Initial Pass/Fail: Fail	Overall Compliance: No
Codes/Mitigation Info/Possible Solution		Field Measurements/Component Compliance

Remove & Replace Entire Refuge.
