Access Compliance Report

Public Rights-of-Way

(Island Curb Cuts)

Intersection ID: 10868	Main Street: N_TRYON_ST	Cross Street: DALTON_AV	Location: SW
ADA ID: 0773AAA0C2C1	Curb Cut Type: IslandRefuge3	Initial Pass/Fail: Pass	Overall Compliance: No
Severity Score: 17.5			
Codes/Mitigation Info/Possible Solution		Field Measurements/Component Compliance

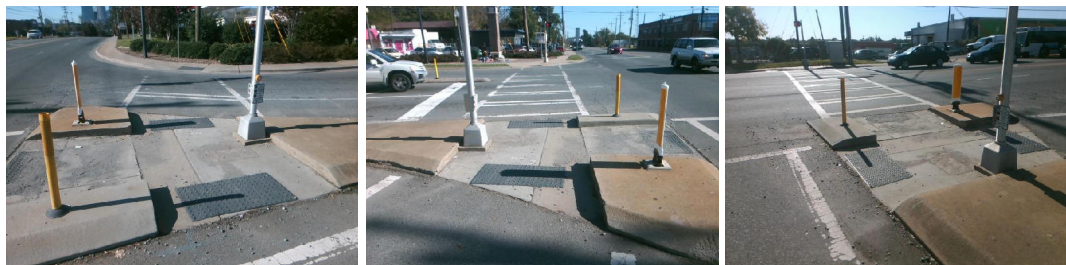
Compliance	Description	Data	Compliance	Description	Data
No	Refuge 1 Length (In)	34.5	Yes	Gutter 1 Ponding?	No
Yes	Refuge 1 Width (In)	85.0	No	Gutter 1 Lip Ht (In)	0.5
Yes	Refuge 1 Slope (%)	0.2	Yes	Gutter 1 Slope (%)	0.6
Yes	Refuge 1 X Slope (%)	0.3	Yes	Gutter 1 X Slope (%)	0.0
N/A	Painted X Walk1?	Yes	No	DWS 1 Provided?	Yes
N/A	X Walk 1 Direction	To SW	N/A	DWS 1 Contrast?	Yes
N/A	X Walk 1 Width (In)	113.5	N/A	DWS 1 Length (In)	24.0
N/A	Road 1 Slope (%)	0.8	N/A	DWS 1 Full Width?	No
N/A	Road 1 X Slope (%)	0.3	N/A	DWS 1 Offset (In)	20.5
No	Refuge 2 Length (In)	30.0	Yes	Gutter 2 Ponding?	No
Yes	Refuge 2 Width (In)	85.0	No	Gutter 2 Lip Ht (In)	0.5
Yes	Refuge 2 Slope (%)	0.8	Yes	Gutter 2 Slope (%)	1.3
Yes	Refuge 2 X Slope (%)	1.8	Yes	Gutter 2 X Slope (%)	1.2
N/A	Painted X Walk2?	Yes	No	DWS 2 Provided?	Yes
N/A	X Walk 2 Direction	To NE	N/A	DWS 2 Contrast?	Yes
N/A	X Walk 2 Width (In)	112.0	N/A	DWS 2 Length (In)	24.0

N/A	Road 2 Slope (%)	1.2	N/A	DWS 2 Full Width?	No
N/A	Road 2 X Slope (%)	0.5	N/A	DWS 2 Offset (In)	2.5
No	Refuge 3 Length (in)	73.0	Yes	Gutter 3 Ponding?	No
Yes	Refuge 3 Width (in)	73.5	Yes	Gutter 3 Lip Ht (in)	0.0
Yes	Refuge 3 Slope (%)	1.7	Yes	Gutter 3 Slope (%)	1.9
Yes	Refuge 3 XSlope (%)	0.3	Yes	Gutter 3 XSlope (%)	1.6
N/A	Painted X Walk3?	Yes	No	DWS 3 Provided?	Yes
N/A	X Walk 3 Direction	To SE	N/A	DWS 3 Contrast?	Yes
N/A	X Walk 3 Width (in)	107.0	N/A	DWS 3 Length (in)	24.0
N/A	Road 3 Slope (%)	1.1	N/A	DWS 3 Full Width?	No
N/A	Road 3 XSlope (%)	1.2	N/A	DWS 3 Offset (in)	2.5
Yes	Any Obstructions?	No	N/A	Storm Grate/Utility Hazard?	No
N/A	Obstruction Type	N/A	N/A	Storm Grate/Utility Type	N/A
N/A	Surface Condition	Good

**Remove & Replace Entire Refuge.
Grind Gutter Lip.**
