Access Compliance Report

Public Rights-of-Way

(Island Curb Cuts)

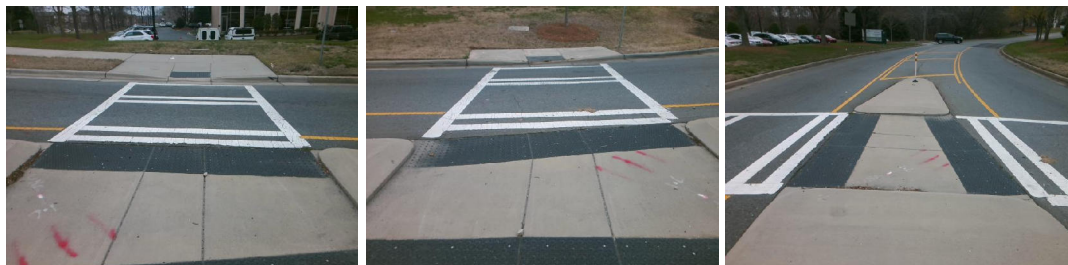
Intersection ID: 52600	Main Street: MCCULLOUGH_DR	Cross Street: IKEA_BV	Location: NW
ADA ID: 0798968FAB78	Curb Cut Type: MedianRefuge2	Initial Pass/Fail: Fail	Overall Compliance: No
Codes/Mitigation Info/Possible Solution		Field Measurements/Component Compliance	
Severity Score: 0

Compliance	Description	Data	Compliance	Description	Data
Yes	Refuge 1 Length (In)	42.0	N/A	Gutter 1 Ponding?	N/A
Yes	Refuge 1 Width (In)	120.5	N/A	Gutter 1 Lip Ht (In)	N/A
Yes	Refuge 1 Slope (%)	1.4	N/A	Gutter 1 Slope (%)	N/A
Yes	Refuge 1 X Slope (%)	2.8	N/A	Gutter 1 X Slope (%)	N/A
N/A	Painted X Walk1?	Yes	N/A	DWS 1 Provided?	N/A
N/A	X Walk 1 Direction	To NW	N/A	DWS 1 Contrast?	N/A
N/A	X Walk 1 Width (In)	110.0	N/A	DWS 1 Length (In)	N/A
N/A	Road 1 Slope (%)	3.6	N/A	DWS 1 Full Width?	N/A
N/A	Road 1 X Slope (%)	4.6	N/A	DWS 1 Offset (In)	N/A
Yes	Refuge 2 Length (In)	42.0	N/A	Gutter 2 Ponding?	N/A
Yes	Refuge 2 Width (In)	120.5	N/A	Gutter 2 Lip Ht (In)	N/A
Yes	Refuge 2 Slope (%)	1.4	N/A	Gutter 2 Slope (%)	N/A
Yes	Refuge 2 X Slope (%)	4.5	N/A	Gutter 2 X Slope (%)	N/A
N/A	Painted X Walk2?	Yes	N/A	DWS 2 Provided?	N/A
N/A	X Walk 2 Direction	To NW	N/A	DWS 2 Contrast?	N/A
N/A	X Walk 2 Width (In)	110.0	N/A	DWS 2 Length (In)	N/A

N/A	Road 2 Slope (%)	5.5	N/A	DWS 2 Full Width?	N/A
N/A	Road 2 X Slope (%)	3.1	N/A	DWS 2 Offset (In)	N/A
N/A	Refuge 3 Length (in)	N/A	N/A	Gutter 3 Ponding?	N/A
N/A	Refuge 3 Width (in)	N/A	N/A	Gutter 3 Lip Ht (in)	N/A
N/A	Refuge 3 Slope (%)	N/A	N/A	Gutter 3 Slope (%)	N/A
N/A	Refuge 3 XSlope (%)	N/A	N/A	Gutter 3 XSlope (%)	N/A
N/A	Painted X Walk3?	N/A	N/A	DWS 3 Provided?	N/A
N/A	X Walk 3 Direction	N/A	N/A	DWS 3 Contrast?	N/A
N/A	X Walk 3 Width (in)	N/A	N/A	DWS 3 Length (in)	N/A
N/A	Road 3 Slope (%)	N/A	N/A	DWS 3 Full Width?	N/A
N/A	Road 3 XSlope (%)	N/A	N/A	DWS 3 Offset (in)	N/A
Yes	Any Obstructions?	N/A	N/A	Storm Grate/Utility Hazard?	N/A
N/A	Obstruction Type		N/A	Storm Grate/Utility Type	
		N/A			N/A
N/A	Surface Condition	Good

Remove & Replace Entire Refuge.
