Access Compliance Report

Public Rights-of-Way

(Island Curb Cuts)

Intersection ID: 10020374	Main Street: BALLANTYNE CORPORATE PCross Street: N/A	Location: SE
ADA ID: 0C278FD85C65	Curb Cut Type: MedianRefuge2	Initial Pass/Fail: Fail
	Overall Compliance: No	Severity Score: 1.25
Codes/Mitigation Info/Possible Solution		Field Measurements/Component Compliance

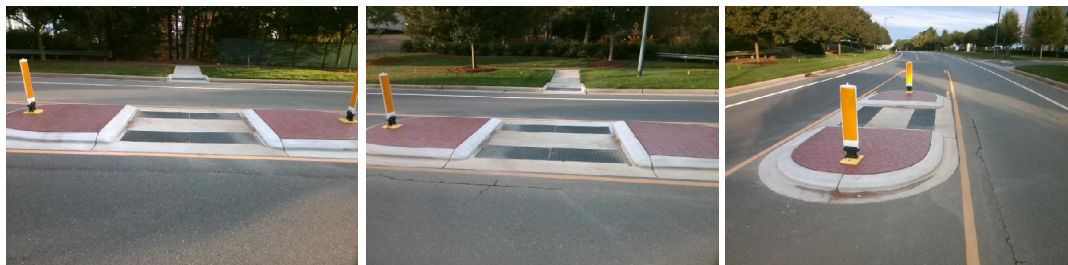
Compliance	Description	Data	Compliance	Description	Data
Yes	Refuge 1 Length (In)	60.5	N/A	Gutter 1 Ponding?	N/A
Yes	Refuge 1 Width (In)	100.0	N/A	Gutter 1 Lip Ht (In)	N/A
Yes	Refuge 1 Slope (%)	3.2	N/A	Gutter 1 Slope (%)	N/A
Yes	Refuge 1 X Slope (%)	2.8	N/A	Gutter 1 X Slope (%)	N/A
N/A	Painted X Walk1?	No	N/A	DWS 1 Provided?	N/A
N/A	X Walk 1 Direction	To SW	N/A	DWS 1 Contrast?	N/A
N/A	X Walk 1 Width (In)	N/A	N/A	DWS 1 Length (In)	N/A
N/A	Road 1 Slope (%)	1.3	N/A	DWS 1 Full Width?	N/A
N/A	Road 1 X Slope (%)	4.9	N/A	DWS 1 Offset (In)	N/A
Yes	Refuge 2 Length (In)	60.5	N/A	Gutter 2 Ponding?	N/A
Yes	Refuge 2 Width (In)	100.0	N/A	Gutter 2 Lip Ht (In)	N/A
Yes	Refuge 2 Slope (%)	2.9	N/A	Gutter 2 Slope (%)	N/A
Yes	Refuge 2 X Slope (%)	3.1	N/A	Gutter 2 X Slope (%)	N/A
N/A	Painted X Walk2?	No	N/A	DWS 2 Provided?	N/A
N/A	X Walk 2 Direction	To NE	N/A	DWS 2 Contrast?	N/A
N/A	X Walk 2 Width (In)	N/A	N/A	DWS 2 Length (In)	N/A

N/A	Road 2 Slope (%)	2.3	N/A	DWS 2 Full Width?	N/A
N/A	Road 2 X Slope (%)	5.1	N/A	DWS 2 Offset (In)	N/A
N/A	Refuge 3 Length (in)	N/A	N/A	Gutter 3 Ponding?	N/A
N/A	Refuge 3 Width (in)	N/A	N/A	Gutter 3 Lip Ht (in)	N/A
N/A	Refuge 3 Slope (%)	N/A	N/A	Gutter 3 Slope (%)	N/A
N/A	Refuge 3 XSlope (%)	N/A	N/A	Gutter 3 XSlope (%)	N/A
N/A	Painted X Walk3?	N/A	N/A	DWS 3 Provided?	N/A
N/A	X Walk 3 Direction	N/A	N/A	DWS 3 Contrast?	N/A
N/A	X Walk 3 Width (in)	N/A	N/A	DWS 3 Length (in)	N/A
N/A	Road 3 Slope (%)	N/A	N/A	DWS 3 Full Width?	N/A
N/A	Road 3 XSlope (%)	N/A	N/A	DWS 3 Offset (in)	N/A
Yes	Any Obstructions?	N/A	N/A	Storm Grate/Utility Hazard?	N/A
N/A	Obstruction Type		N/A	Storm Grate/Utility Type	
		N/A			N/A
N/A	Surface Condition	Good

Remove & Replace Entire Refuge.

Total Cost: \$ 3000.00
