Access Compliance Report

Public Rights-of-Way

(Island Curb Cuts)

| Intersection ID: 10180 | Main Street: FERN_AV | Cross Street: TUCKASEEGEE_RD | Location: N |

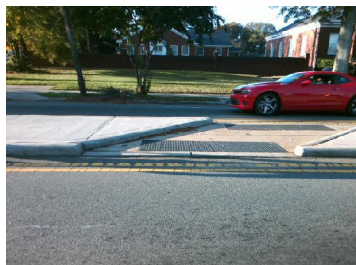
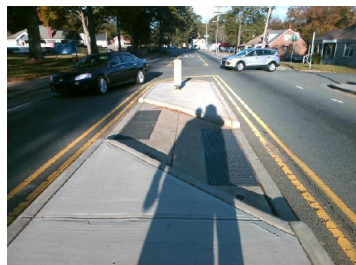
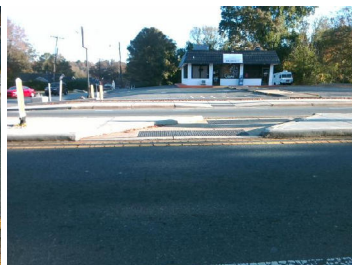
| ADA ID: 0FBC3A7DFBF0 | Curb Cut Type: MedianRefuge2 | Initial Pass/Fail: Fail | Overall Compliance: No |

Remove & Replace Entire Refuge.
