Access Compliance Report

Public Rights-of-Way

(Island Curb Cuts)

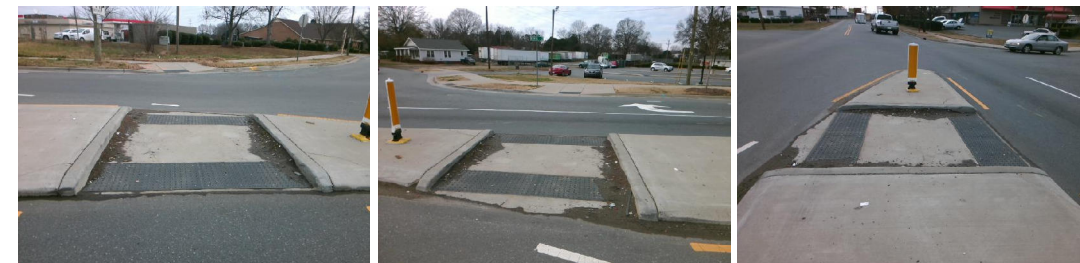
Intersection ID: 43188	Main Street: HOVIS_RD	Cross Street: SALEM_CHURCH_RD	Location:	N
ADA ID: 100D705250C2	Curb Cut Type: MedianRefuge2	Initial Pass/Fail: Pass	Overall Compliance: No	Severity Score: 10.25
Codes/Mitigation Info/Possible Solution		Field Measurements/Component Compliance

Remove & Replace Detectable Warning System. Fix Gutter Ponding. Remove & Replace Gutter.
