Access Compliance Report

Public Rights-of-Way

(Island Curb Cuts)

Intersection ID: 47611	Main Street: WYALONG_DR	Cross Street: MINTWORTH_AV	Location: SW
ADA ID: 1147B7287202	Curb Cut Type: MedianRefuge2	Initial Pass/Fail: Fail	Overall Compliance: No
Codes/Mitigation Info/Possible Solution		Field Measurements/Component Compliance

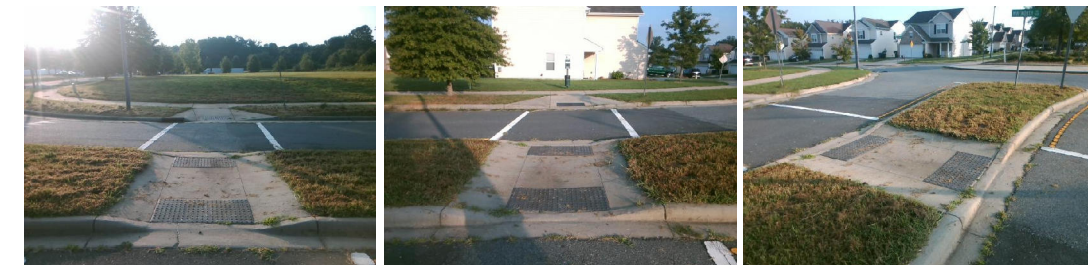
Compliance	Description	Data	Compliance	Description	Data
Yes	Refuge 1 Length (In)	51.0	N/A	Gutter 1 Ponding?	N/A
No	Refuge 1 Width (In)	49.0	N/A	Gutter 1 Lip Ht (In)	N/A
Yes	Refuge 1 Slope (%)	1.1	N/A	Gutter 1 Slope (%)	N/A
No	Refuge 1 X Slope (%)	5.2	N/A	Gutter 1 X Slope (%)	N/A
N/A	Painted X Walk1?	Yes	N/A	DWS 1 Provided?	N/A
N/A	X Walk 1 Direction	To SE	N/A	DWS 1 Contrast?	N/A
N/A	X Walk 1 Width (In)	119.0	N/A	DWS 1 Length (In)	N/A
N/A	Road 1 Slope (%)	2.1	N/A	DWS 1 Full Width?	N/A
N/A	Road 1 X Slope (%)	2.7	N/A	DWS 1 Offset (In)	N/A
Yes	Refuge 2 Length (In)	51.0	N/A	Gutter 2 Ponding?	N/A
No	Refuge 2 Width (In)	49.0	N/A	Gutter 2 Lip Ht (In)	N/A
Yes	Refuge 2 Slope (%)	0.1	N/A	Gutter 2 Slope (%)	N/A
Yes	Refuge 2 X Slope (%)	3.9	N/A	Gutter 2 X Slope (%)	N/A
N/A	Painted X Walk2?	Yes	N/A	DWS 2 Provided?	N/A
N/A	X Walk 2 Direction	To NW	N/A	DWS 2 Contrast?	N/A
N/A	X Walk 2 Width (In)	119.0	N/A	DWS 2 Length (In)	N/A

N/A	Road 2 Slope (%)	3.1	N/A	DWS 2 Full Width?	N/A
N/A	Road 2 X Slope (%)	1.0	N/A	DWS 2 Offset (In)	N/A
N/A	Refuge 3 Length (in)	N/A	N/A	Gutter 3 Ponding?	N/A
N/A	Refuge 3 Width (in)	N/A	N/A	Gutter 3 Lip Ht (in)	N/A
N/A	Refuge 3 Slope (%)	N/A	N/A	Gutter 3 Slope (%)	N/A
N/A	Refuge 3 XSlope (%)	N/A	N/A	Gutter 3 XSlope (%)	N/A
N/A	Painted X Walk3?	N/A	N/A	DWS 3 Provided?	N/A
N/A	X Walk 3 Direction	N/A	N/A	DWS 3 Contrast?	N/A
N/A	X Walk 3 Width (in)	N/A	N/A	DWS 3 Length (in)	N/A
N/A	Road 3 Slope (%)	N/A	N/A	DWS 3 Full Width?	N/A
N/A	Road 3 XSlope (%)	N/A	N/A	DWS 3 Offset (in)	N/A
Yes	Any Obstructions?	N/A	N/A	Storm Grate/Utility Hazard?	N/A
N/A	Obstruction Type		N/A	Storm Grate/Utility Type	
		N/A			N/A
N/A	Surface Condition	Good

Remove & Replace Entire Refuge.
