Access Compliance Report

Public Rights-of-Way

(Island Curb Cuts)

Intersection ID: 17772	Main Street: IDLEWILD_RD	Cross Street: VALLEY_GROVE_RD	Location: SE
ADA ID: 1459B65D0C0B	Curb Cut Type: MedianRefuge2	Initial Pass/Fail: Fail	Overall Compliance: No
Codes/Mitigation Info/Possible Solution		Field Measurements/Component Compliance	
Severity Score: 25

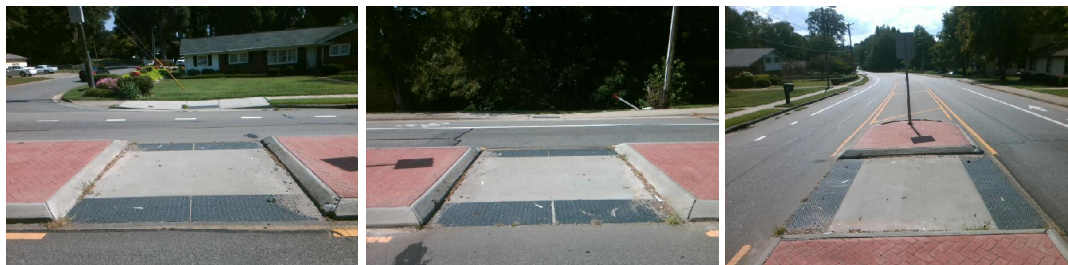
Compliance	Description	Data	Compliance	Description	Data
Yes	Refuge 1 Length (In)	65.0	N/A	Gutter 1 Ponding?	N/A
Yes	Refuge 1 Width (In)	121.0	N/A	Gutter 1 Lip Ht (In)	N/A
No	Refuge 1 Slope (%)	5.8	N/A	Gutter 1 Slope (%)	N/A
Yes	Refuge 1 X Slope (%)	4.9	N/A	Gutter 1 X Slope (%)	N/A
N/A	Painted X Walk1?	No	N/A	DWS 1 Provided?	N/A
N/A	X Walk 1 Direction	To NE	N/A	DWS 1 Contrast?	N/A
N/A	X Walk 1 Width (In)	N/A	N/A	DWS 1 Length (In)	N/A
N/A	Road 1 Slope (%)	3.8	N/A	DWS 1 Full Width?	N/A
N/A	Road 1 X Slope (%)	6.2	N/A	DWS 1 Offset (In)	N/A
Yes	Refuge 2 Length (In)	65.0	N/A	Gutter 2 Ponding?	N/A
Yes	Refuge 2 Width (In)	121.0	N/A	Gutter 2 Lip Ht (In)	N/A
Yes	Refuge 2 Slope (%)	1.5	N/A	Gutter 2 Slope (%)	N/A
No	Refuge 2 X Slope (%)	5.3	N/A	Gutter 2 X Slope (%)	N/A
N/A	Painted X Walk2?	No	N/A	DWS 2 Provided?	N/A
N/A	X Walk 2 Direction	To SW	N/A	DWS 2 Contrast?	N/A
N/A	X Walk 2 Width (In)	N/A	N/A	DWS 2 Length (In)	N/A

N/A	Road 2 Slope (%)	4.9	N/A	DWS 2 Full Width?	N/A
N/A	Road 2 X Slope (%)	0.6	N/A	DWS 2 Offset (In)	N/A
N/A	Refuge 3 Length (in)	N/A	N/A	Gutter 3 Ponding?	N/A
N/A	Refuge 3 Width (in)	N/A	N/A	Gutter 3 Lip Ht (in)	N/A
N/A	Refuge 3 Slope (%)	N/A	N/A	Gutter 3 Slope (%)	N/A
N/A	Refuge 3 XSlope (%)	N/A	N/A	Gutter 3 XSlope (%)	N/A
N/A	Painted X Walk3?	N/A	N/A	DWS 3 Provided?	N/A
N/A	X Walk 3 Direction	N/A	N/A	DWS 3 Contrast?	N/A
N/A	X Walk 3 Width (in)	N/A	N/A	DWS 3 Length (in)	N/A
N/A	Road 3 Slope (%)	N/A	N/A	DWS 3 Full Width?	N/A
N/A	Road 3 XSlope (%)	N/A	N/A	DWS 3 Offset (in)	N/A
Yes	Any Obstructions?	N/A	N/A	Storm Grate/Utility Hazard?	N/A
N/A	Obstruction Type		N/A	Storm Grate/Utility Type	
		N/A			N/A
N/A	Surface Condition	Good

Possible Solutions:

Remove & Replace Entire Refuge.

Total Cost: \$ 3000.00
