Access Compliance Report

Public Rights-of-Way

(Island Curb Cuts)

Intersection ID: 27397	Main Street: ELM_LN	Cross Street: BALLANTYNE_COMMONS_PY	Location: E
ADA ID: 16D8A42EAAF5	Curb Cut Type: MedianRefuge2	Initial Pass/Fail: Fail	Overall Compliance: No
Codes/Mitigation Info/Possible Solution		Field Measurements/Component Compliance	
Severity Score: 0

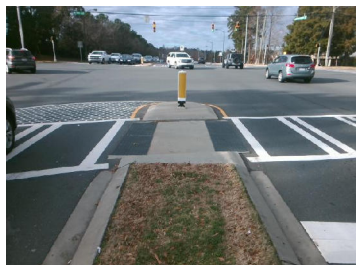
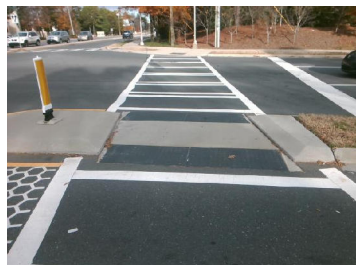
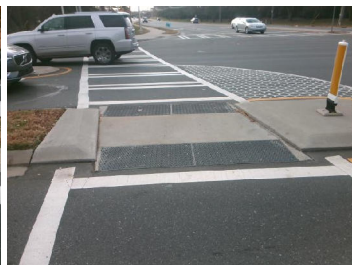
Compliance	Description	Data	Compliance	Description	Data
Yes	Refuge 1 Length (In)	48.0	N/A	Gutter 1 Ponding?	N/A
Yes	Refuge 1 Width (In)	98.0	N/A	Gutter 1 Lip Ht (In)	N/A
Yes	Refuge 1 Slope (%)	1.6	N/A	Gutter 1 Slope (%)	N/A
Yes	Refuge 1 X Slope (%)	2.8	N/A	Gutter 1 X Slope (%)	N/A
N/A	Painted X Walk1?	Yes	N/A	DWS 1 Provided?	N/A
N/A	X Walk 1 Direction	To NW	N/A	DWS 1 Contrast?	N/A
N/A	X Walk 1 Width (In)	113.0	N/A	DWS 1 Length (In)	N/A
N/A	Road 1 Slope (%)	0.8	N/A	DWS 1 Full Width?	N/A
N/A	Road 1 X Slope (%)	3.9	N/A	DWS 1 Offset (In)	N/A
Yes	Refuge 2 Length (In)	48.0	N/A	Gutter 2 Ponding?	N/A
Yes	Refuge 2 Width (In)	98.0	N/A	Gutter 2 Lip Ht (In)	N/A
Yes	Refuge 2 Slope (%)	2.0	N/A	Gutter 2 Slope (%)	N/A
Yes	Refuge 2 X Slope (%)	1.4	N/A	Gutter 2 X Slope (%)	N/A
N/A	Painted X Walk2?	Yes	N/A	DWS 2 Provided?	N/A
N/A	X Walk 2 Direction	To SE	N/A	DWS 2 Contrast?	N/A
N/A	X Walk 2 Width (In)	114.0	N/A	DWS 2 Length (In)	N/A

N/A	Road 2 Slope (%)	0.9	N/A	DWS 2 Full Width?	N/A
N/A	Road 2 X Slope (%)	0.3	N/A	DWS 2 Offset (In)	N/A
N/A	Refuge 3 Length (in)	N/A	N/A	Gutter 3 Ponding?	N/A
N/A	Refuge 3 Width (in)	N/A	N/A	Gutter 3 Lip Ht (in)	N/A
N/A	Refuge 3 Slope (%)	N/A	N/A	Gutter 3 Slope (%)	N/A
N/A	Refuge 3 XSlope (%)	N/A	N/A	Gutter 3 XSlope (%)	N/A
N/A	Painted X Walk3?	N/A	N/A	DWS 3 Provided?	N/A
N/A	X Walk 3 Direction	N/A	N/A	DWS 3 Contrast?	N/A
N/A	X Walk 3 Width (in)	N/A	N/A	DWS 3 Length (in)	N/A
N/A	Road 3 Slope (%)	N/A	N/A	DWS 3 Full Width?	N/A
N/A	Road 3 XSlope (%)	N/A	N/A	DWS 3 Offset (in)	N/A
Yes	Any Obstructions?	N/A	N/A	Storm Grate/Utility Hazard?	N/A
N/A	Obstruction Type		N/A	Storm Grate/Utility Type	
		N/A			N/A
N/A	Surface Condition	Good

Remove & Replace Entire Refuge.
