Access Compliance Report

Public Rights-of-Way

(Island Curb Cuts)

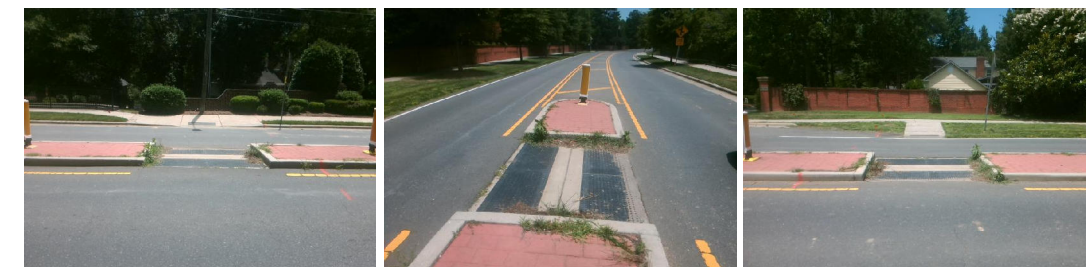
Compliance	Description	Data	Compliance	Description	Data
Yes	Refuge 1 Length (In)	36.0	Yes	Gutter 1 Ponding?	No
Yes	Refuge 1 Width (In)	99.0	Yes	Gutter 1 Lip Ht (In)	0.0
Yes	Refuge 1 Slope (%)	3.2	Yes	Gutter 1 Slope (%)	0.9
Yes	Refuge 1 X Slope (%)	0.1	Yes	Gutter 1 X Slope (%)	0.0
N/A	Painted X Walk1?	No	Yes	DWS 1 Provided?	Yes
N/A	X Walk 1 Direction	To NW	Yes	DWS 1 Contrast?	Yes
N/A	X Walk 1 Width (In)	N/A	Yes	DWS 1 Length (In)	24.5
N/A	Road 1 Slope (%)	0.6	Yes	DWS 1 Full Width?	Yes
N/A	Road 1 X Slope (%)	1.3	No	DWS 1 Offset (In)	3.5
Yes	Refuge 2 Length (In)	36.0	Yes	Gutter 2 Ponding?	No
Yes	Refuge 2 Width (In)	99.0	Yes	Gutter 2 Lip Ht (In)	0.0
Yes	Refuge 2 Slope (%)	4.0	Yes	Gutter 2 Slope (%)	1.9
Yes	Refuge 2 X Slope (%)	0.1	Yes	Gutter 2 X Slope (%)	0.9
N/A	Painted X Walk2?	No	Yes	DWS 2 Provided?	Yes
N/A	X Walk 2 Direction	To SE	Yes	DWS 2 Contrast?	Yes
N/A	X Walk 2 Width (In)	N/A	Yes	DWS 2 Length (In)	24.5

N/A	Road 2 Slope (%)	0.5	Yes	DWS 2 Full Width?	Yes
N/A	Road 2 X Slope (%)	3.9	No	DWS 2 Offset (In)	3.5
N/A	Refuge 3 Length (in)	N/A	N/A	Gutter 3 Ponding?	N/A
N/A	Refuge 3 Width (in)	N/A	N/A	Gutter 3 Lip Ht (in)	N/A
N/A	Refuge 3 Slope (%)	N/A	N/A	Gutter 3 Slope (%)	N/A
N/A	Refuge 3 XSlope (%)	N/A	N/A	Gutter 3 XSlope (%)	N/A
N/A	Painted X Walk3?	N/A	N/A	DWS 3 Provided?	N/A
N/A	X Walk 3 Direction	N/A	N/A	DWS 3 Contrast?	N/A
N/A	X Walk 3 Width (in)	N/A	N/A	DWS 3 Length (in)	N/A
N/A	Road 3 Slope (%)	N/A	N/A	DWS 3 Full Width?	N/A
N/A	Road 3 XSlope (%)	N/A	N/A	DWS 3 Offset (in)	N/A
Yes	Any Obstructions?	No	N/A	Storm Grate/Utility Hazard?	No
N/A	Obstruction Type		N/A	Storm Grate/Utility Type	
		N/A			N/A
N/A	Surface Condition	Good

Possible Solutions:

Remove & Replace Detectable Warning System.
