# Access Compliance Report

## Public Rights-of-Way

### (Island Curb Cuts)

Intersection ID: 47099	Main Street: GALLERIA_BV	Cross Street: N/A	Location: W
ADA ID: 1AD56FF0DA47	Curb Cut Type: MedianRefuge2	Initial Pass/Fail: Fail	Overall Compliance: No
Codes/Mitigation Info/Possible Solution		Field Measurements/Component Compliance

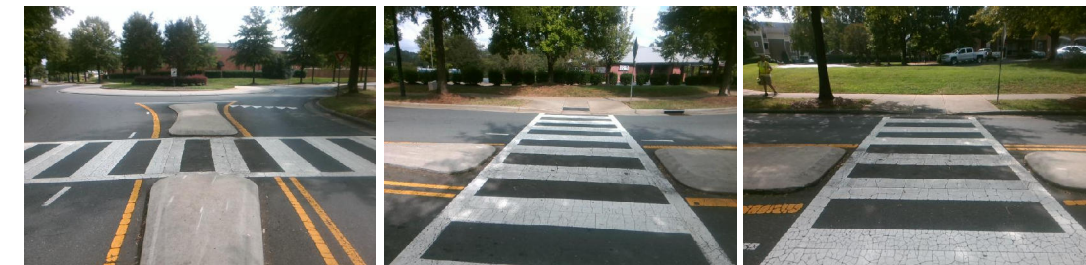
Compliance	Description	Data	Compliance	Description	Data
No	Refuge 1 Length (In)	30.0	N/A	Gutter 1 Ponding?	N/A
Yes	Refuge 1 Width (In)	120.0	N/A	Gutter 1 Lip Ht (In)	N/A
Yes	Refuge 1 Slope (%)	0.4	N/A	Gutter 1 Slope (%)	N/A
No	Refuge 1 X Slope (%)	6.4	N/A	Gutter 1 X Slope (%)	N/A
N/A	Painted X Walk1?	Yes	N/A	DWS 1 Provided?	N/A
N/A	X Walk 1 Direction	To S	N/A	DWS 1 Contrast?	N/A
N/A	X Walk 1 Width (In)	100.0	N/A	DWS 1 Length (In)	N/A
N/A	Road 1 Slope (%)	2.5	N/A	DWS 1 Full Width?	N/A
N/A	Road 1 X Slope (%)	4.7	N/A	DWS 1 Offset (In)	N/A
No	Refuge 2 Length (In)	30.0	N/A	Gutter 2 Ponding?	N/A
Yes	Refuge 2 Width (In)	120.0	N/A	Gutter 2 Lip Ht (In)	N/A
Yes	Refuge 2 Slope (%)	1.6	N/A	Gutter 2 Slope (%)	N/A
Yes	Refuge 2 X Slope (%)	0.9	N/A	Gutter 2 X Slope (%)	N/A
N/A	Painted X Walk2?	Yes	N/A	DWS 2 Provided?	N/A
N/A	X Walk 2 Direction	To N	N/A	DWS 2 Contrast?	N/A
N/A	X Walk 2 Width (In)	100.0	N/A	DWS 2 Length (In)	N/A

N/A	Road 2 Slope (%)	2.5	N/A	DWS 2 Full Width?	N/A
N/A	Road 2 X Slope (%)	1.7	N/A	DWS 2 Offset (In)	N/A
N/A	Refuge 3 Length (in)	N/A	N/A	Gutter 3 Ponding?	N/A
N/A	Refuge 3 Width (in)	N/A	N/A	Gutter 3 Lip Ht (in)	N/A
N/A	Refuge 3 Slope (%)	N/A	N/A	Gutter 3 Slope (%)	N/A
N/A	Refuge 3 XSlope (%)	N/A	N/A	Gutter 3 XSlope (%)	N/A
N/A	Painted X Walk3?	N/A	N/A	DWS 3 Provided?	N/A
N/A	X Walk 3 Direction	N/A	N/A	DWS 3 Contrast?	N/A
N/A	X Walk 3 Width (in)	N/A	N/A	DWS 3 Length (in)	N/A
N/A	Road 3 Slope (%)	N/A	N/A	DWS 3 Full Width?	N/A
N/A	Road 3 XSlope (%)	N/A	N/A	DWS 3 Offset (in)	N/A
Yes	Any Obstructions?	N/A	N/A	Storm Grate/Utility Hazard?	N/A
N/A	Obstruction Type		N/A	Storm Grate/Utility Type	
		N/A			N/A
N/A	Surface Condition	Good

**Remove & Replace Entire Refuge.**
