Access Compliance Report

Public Rights-of-Way

(Island Curb Cuts)

Intersection ID: 47611	Main Street: WYALONG_DR	Cross Street: MINTWORTH_AV	Location: NE
ADA ID: 1B26A0251C47	Curb Cut Type: MedianRefuge2	Initial Pass/Fail: Fail	Overall Compliance: No
Codes/Mitigation Info/Possible Solution		Field Measurements/Component Compliance	
Severity Score: 8.75

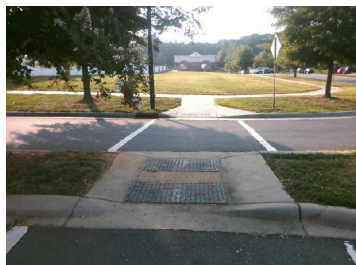
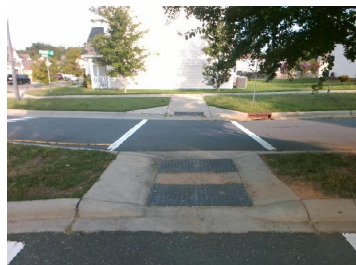
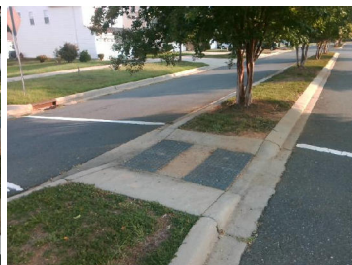
Compliance	Description	Data	Compliance	Description	Data
No	Refuge 1 Length (In)	32.5	N/A	Gutter 1 Ponding?	N/A
No	Refuge 1 Width (In)	48.0	N/A	Gutter 1 Lip Ht (In)	N/A
Yes	Refuge 1 Slope (%)	0.6	N/A	Gutter 1 Slope (%)	N/A
Yes	Refuge 1 X Slope (%)	2.6	N/A	Gutter 1 X Slope (%)	N/A
N/A	Painted X Walk1?	Yes	N/A	DWS 1 Provided?	N/A
N/A	X Walk 1 Direction	To SE	N/A	DWS 1 Contrast?	N/A
N/A	X Walk 1 Width (In)	119.0	N/A	DWS 1 Length (In)	N/A
N/A	Road 1 Slope (%)	0.4	N/A	DWS 1 Full Width?	N/A
N/A	Road 1 X Slope (%)	6.0	N/A	DWS 1 Offset (In)	N/A
No	Refuge 2 Length (In)	32.5	N/A	Gutter 2 Ponding?	N/A
No	Refuge 2 Width (In)	48.0	N/A	Gutter 2 Lip Ht (In)	N/A
Yes	Refuge 2 Slope (%)	0.0	N/A	Gutter 2 Slope (%)	N/A
Yes	Refuge 2 X Slope (%)	3.0	N/A	Gutter 2 X Slope (%)	N/A
N/A	Painted X Walk2?	Yes	N/A	DWS 2 Provided?	N/A
N/A	X Walk 2 Direction	To NW	N/A	DWS 2 Contrast?	N/A
N/A	X Walk 2 Width (In)	119.0	N/A	DWS 2 Length (In)	N/A

N/A	Road 2 Slope (%)	1.1	N/A	DWS 2 Full Width?	N/A
N/A	Road 2 X Slope (%)	3.1	N/A	DWS 2 Offset (In)	N/A
N/A	Refuge 3 Length (in)	N/A	N/A	Gutter 3 Ponding?	N/A
N/A	Refuge 3 Width (in)	N/A	N/A	Gutter 3 Lip Ht (in)	N/A
N/A	Refuge 3 Slope (%)	N/A	N/A	Gutter 3 Slope (%)	N/A
N/A	Refuge 3 XSlope (%)	N/A	N/A	Gutter 3 XSlope (%)	N/A
N/A	Painted X Walk3?	N/A	N/A	DWS 3 Provided?	N/A
N/A	X Walk 3 Direction	N/A	N/A	DWS 3 Contrast?	N/A
N/A	X Walk 3 Width (in)	N/A	N/A	DWS 3 Length (in)	N/A
N/A	Road 3 Slope (%)	N/A	N/A	DWS 3 Full Width?	N/A
N/A	Road 3 XSlope (%)	N/A	N/A	DWS 3 Offset (in)	N/A
Yes	Any Obstructions?	N/A	N/A	Storm Grate/Utility Hazard?	N/A
N/A	Obstruction Type		N/A	Storm Grate/Utility Type	
		N/A			N/A
N/A	Surface Condition	Good

Possible Solutions:

Remove & Replace Entire Refuge.
