# Access Compliance Report

## Public Rights-of-Way

### (Island Curb Cuts)

Intersection ID: 10011809	Main Street: STATESVILLE_RD	Cross Street: N/A	Location: N
ADA ID: 1B36F051ED7C	Curb Cut Type: MedianRefuge2	Initial Pass/Fail: Pass	Overall Compliance: No
		Severity Score: 0

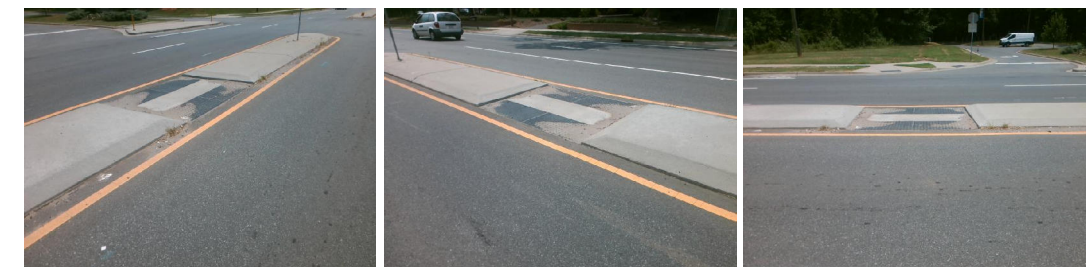
Compliance	Description	Data	Compliance	Description	Data
Yes	Refuge 1 Length (In)	36.5	Yes	Gutter 1 Ponding?	No
Yes	Refuge 1 Width (In)	96.0	No	Gutter 1 Lip Ht (In)	0.25
Yes	Refuge 1 Slope (%)	1.5	Yes	Gutter 1 Slope (%)	2.1
Yes	Refuge 1 X Slope (%)	0.0	Yes	Gutter 1 X Slope (%)	0.8
N/A	Painted X Walk1?	No	Yes	DWS 1 Provided?	Yes
N/A	X Walk 1 Direction	To E	Yes	DWS 1 Contrast?	Yes
N/A	X Walk 1 Width (In)	N/A	Yes	DWS 1 Length (In)	24.0
N/A	Road 1 Slope (%)	0.6	Yes	DWS 1 Full Width?	Yes
N/A	Road 1 X Slope (%)	1.7	Yes	DWS 1 Offset (In)	0.0
Yes	Refuge 2 Length (In)	36.5	Yes	Gutter 2 Ponding?	No
Yes	Refuge 2 Width (In)	96.0	No	Gutter 2 Lip Ht (In)	0.25
Yes	Refuge 2 Slope (%)	1.0	Yes	Gutter 2 Slope (%)	1.9
Yes	Refuge 2 X Slope (%)	0.3	Yes	Gutter 2 X Slope (%)	0.0
N/A	Painted X Walk2?	No	Yes	DWS 2 Provided?	Yes
N/A	X Walk 2 Direction	To W	Yes	DWS 2 Contrast?	Yes
N/A	X Walk 2 Width (In)	N/A	Yes	DWS 2 Length (In)	24.0

N/A	Road 2 Slope (%)	0.2	Yes	DWS 2 Full Width?	Yes
N/A	Road 2 X Slope (%)	2.2	Yes	DWS 2 Offset (In)	0.0
N/A	Refuge 3 Length (in)	N/A	N/A	Gutter 3 Ponding?	No
N/A	Refuge 3 Width (in)	N/A	N/A	Gutter 3 Lip Ht (in)	N/A
N/A	Refuge 3 Slope (%)	N/A	N/A	Gutter 3 Slope (%)	N/A
N/A	Refuge 3 XSlope (%)	N/A	N/A	Gutter 3 XSlope (%)	N/A
N/A	Painted X Walk3?	No	N/A	DWS 3 Provided?	N/A
N/A	X Walk 3 Direction	N/A	N/A	DWS 3 Contrast?	N/A
N/A	X Walk 3 Width (in)	N/A	N/A	DWS 3 Length (in)	N/A
N/A	Road 3 Slope (%)	N/A	N/A	DWS 3 Full Width?	N/A
N/A	Road 3 XSlope (%)	N/A	N/A	DWS 3 Offset (in)	N/A
Yes	Any Obstructions?	No	N/A	Storm Grate/Utility Hazard?	No
N/A	Obstruction Type		N/A	Storm Grate/Utility Type	
		N/A			N/A
N/A	Surface Condition	Good

Possible Solutions:

**Grind Gutter Lip.**
