Access Compliance Report

Public Rights-of-Way

(Island Curb Cuts)

Intersection ID: 3276	Main Street: LAKE_SPRING_AV	Cross Street: W_W_T_HARRIS_BV	Location: SW
ADA ID: 1B6E5977B007	Curb Cut Type: MedianRefuge2	Initial Pass/Fail: Pass	Overall Compliance: No
Severity Score: 0.25			
Codes/Mitigation Info/Possible Solution		Field Measurements/Component Compliance

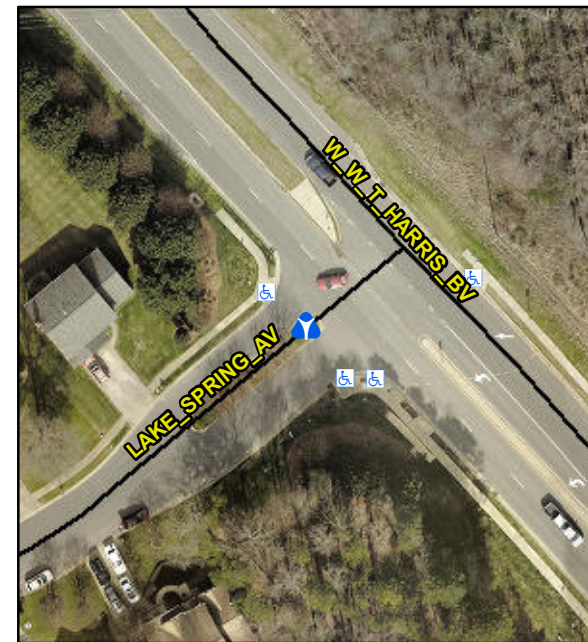
Compliance	Description	Data	Compliance	Description	Data
Yes	Refuge 1 Length (In)	58.5	Yes	Gutter 1 Ponding?	No
Yes	Refuge 1 Width (In)	60.0	Yes	Gutter 1 Lip Ht (In)	0.0
Yes	Refuge 1 Slope (%)	2.9	Yes	Gutter 1 Slope (%)	3.2
Yes	Refuge 1 X Slope (%)	0.3	Yes	Gutter 1 X Slope (%)	1.7
N/A	Painted X Walk1?	No	Yes	DWS 1 Provided?	Yes
N/A	X Walk 1 Direction	To SE	Yes	DWS 1 Contrast?	Yes
N/A	X Walk 1 Width (In)	N/A	Yes	DWS 1 Length (In)	24.0
N/A	Road 1 Slope (%)	1.3	Yes	DWS 1 Full Width?	Yes
N/A	Road 1 X Slope (%)	1.5	No	DWS 1 Offset (In)	4.0
Yes	Refuge 2 Length (In)	58.5	Yes	Gutter 2 Ponding?	No
Yes	Refuge 2 Width (In)	60.0	Yes	Gutter 2 Lip Ht (In)	0.0
Yes	Refuge 2 Slope (%)	1.0	Yes	Gutter 2 Slope (%)	4.6
Yes	Refuge 2 X Slope (%)	0.1	Yes	Gutter 2 X Slope (%)	0.4
N/A	Painted X Walk2?	No	Yes	DWS 2 Provided?	Yes
N/A	X Walk 2 Direction	To NW	Yes	DWS 2 Contrast?	Yes
N/A	X Walk 2 Width (In)	N/A	Yes	DWS 2 Length (In)	24.0

N/A	Road 2 Slope (%)	0.5	Yes	DWS 2 Full Width?	Yes
N/A	Road 2 X Slope (%)	1.6	No	DWS 2 Offset (In)	4.0
N/A	Refuge 3 Length (in)	N/A	N/A	Gutter 3 Ponding?	N/A
N/A	Refuge 3 Width (in)	N/A	N/A	Gutter 3 Lip Ht (in)	N/A
N/A	Refuge 3 Slope (%)	N/A	N/A	Gutter 3 Slope (%)	N/A
N/A	Refuge 3 XSlope (%)	N/A	N/A	Gutter 3 XSlope (%)	N/A
N/A	Painted X Walk3?	N/A	N/A	DWS 3 Provided?	N/A
N/A	X Walk 3 Direction	N/A	N/A	DWS 3 Contrast?	N/A
N/A	X Walk 3 Width (in)	N/A	N/A	DWS 3 Length (in)	N/A
N/A	Road 3 Slope (%)	N/A	N/A	DWS 3 Full Width?	N/A
N/A	Road 3 XSlope (%)	N/A	N/A	DWS 3 Offset (in)	N/A
Yes	Any Obstructions?	No	N/A	Storm Grate/Utility Hazard?	No
N/A	Obstruction Type		N/A	Storm Grate/Utility Type	
		N/A			N/A
N/A	Surface Condition	Good

Possible Solutions:

Remove & Replace Detectable Warning System.
