Access Compliance Report

Public Rights-of-Way

(Island Curb Cuts)

Intersection ID: 10038340	Main Street: SOUTH_BV	Cross Street: N/A	Location: S
ADA ID: 1C39A1E43F81	Curb Cut Type: MedianRefuge2	Initial Pass/Fail: Fail	Overall Compliance: No
Codes/Mitigation Info/Possible Solution		Field Measurements/Component Compliance

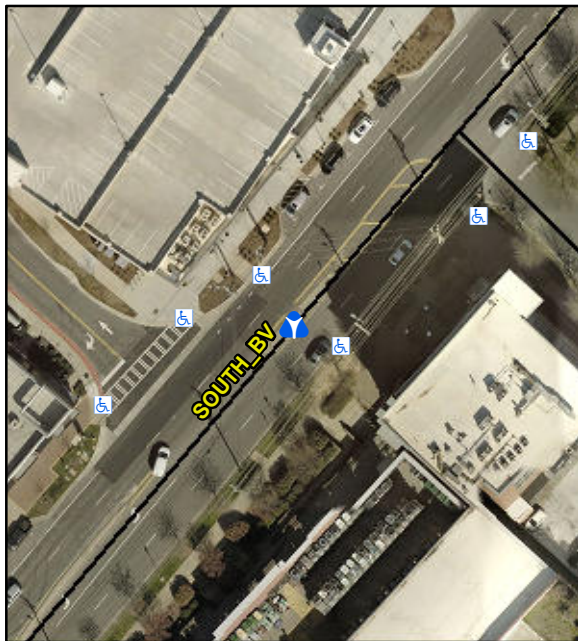
Compliance	Description	Data	Compliance	Description	Data
No	Refuge 1 Length (In)	31.0	N/A	Gutter 1 Ponding?	N/A
Yes	Refuge 1 Width (In)	98.0	N/A	Gutter 1 Lip Ht (In)	N/A
Yes	Refuge 1 Slope (%)	1.2	N/A	Gutter 1 Slope (%)	N/A
Yes	Refuge 1 X Slope (%)	2.6	N/A	Gutter 1 X Slope (%)	N/A
N/A	Painted X Walk1?	No	N/A	DWS 1 Provided?	N/A
N/A	X Walk 1 Direction	To SE	N/A	DWS 1 Contrast?	N/A
N/A	X Walk 1 Width (In)	N/A	N/A	DWS 1 Length (In)	N/A
N/A	Road 1 Slope (%)	2.8	N/A	DWS 1 Full Width?	N/A
N/A	Road 1 X Slope (%)	2.2	N/A	DWS 1 Offset (In)	N/A
No	Refuge 2 Length (In)	31.0	N/A	Gutter 2 Ponding?	N/A
Yes	Refuge 2 Width (In)	98.0	N/A	Gutter 2 Lip Ht (In)	N/A
Yes	Refuge 2 Slope (%)	4.0	N/A	Gutter 2 Slope (%)	N/A
Yes	Refuge 2 X Slope (%)	1.0	N/A	Gutter 2 X Slope (%)	N/A
N/A	Painted X Walk2?	No	N/A	DWS 2 Provided?	N/A
N/A	X Walk 2 Direction	To NW	N/A	DWS 2 Contrast?	N/A
N/A	X Walk 2 Width (In)	N/A	N/A	DWS 2 Length (In)	N/A

N/A	Road 2 Slope (%)	0.6	N/A	DWS 2 Full Width?	N/A
N/A	Road 2 X Slope (%)	2.7	N/A	DWS 2 Offset (In)	N/A
N/A	Refuge 3 Length (in)	N/A	N/A	Gutter 3 Ponding?	N/A
N/A	Refuge 3 Width (in)	N/A	N/A	Gutter 3 Lip Ht (in)	N/A
N/A	Refuge 3 Slope (%)	N/A	N/A	Gutter 3 Slope (%)	N/A
N/A	Refuge 3 XSlope (%)	N/A	N/A	Gutter 3 XSlope (%)	N/A
N/A	Painted X Walk3?	N/A	N/A	DWS 3 Provided?	N/A
N/A	X Walk 3 Direction	N/A	N/A	DWS 3 Contrast?	N/A
N/A	X Walk 3 Width (in)	N/A	N/A	DWS 3 Length (in)	N/A
N/A	Road 3 Slope (%)	N/A	N/A	DWS 3 Full Width?	N/A
N/A	Road 3 XSlope (%)	N/A	N/A	DWS 3 Offset (in)	N/A
Yes	Any Obstructions?	N/A	N/A	Storm Grate/Utility Hazard?	N/A
N/A	Obstruction Type		N/A	Storm Grate/Utility Type	
		N/A			N/A
N/A	Surface Condition	Good

Possible Solutions:

Remove & Replace Entire Refuge.
