Access Compliance Report

Public Rights-of-Way

(Island Curb Cuts)

Intersection ID: 10390	Main Street: ENDERLY_RD	Cross Street: TUCKASEEGEE_RD	Location: S
ADA ID: 1C74069F13D5	Curb Cut Type: MedianRefuge2	Initial Pass/Fail: Fail	Overall Compliance: No
Codes/Mitigation Info/Possible Solution		Field Measurements/Component Compliance	
Severity Score: 25

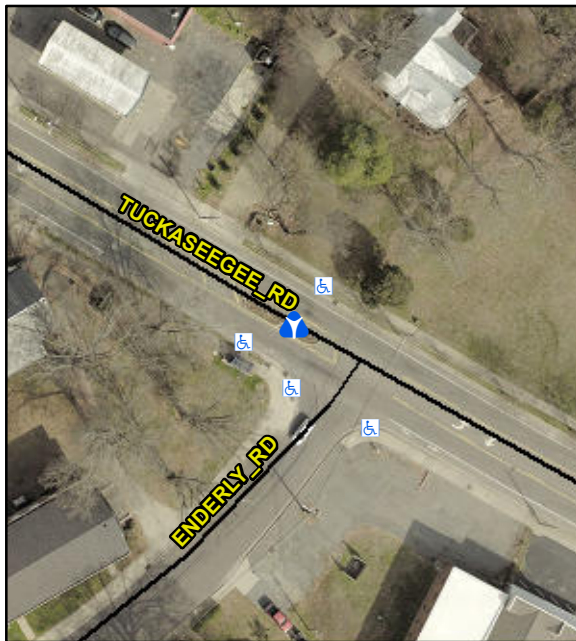
Compliance	Description	Data	Compliance	Description	Data
Yes	Refuge 1 Length (In)	61.0	N/A	Gutter 1 Ponding?	N/A
Yes	Refuge 1 Width (In)	124.0	N/A	Gutter 1 Lip Ht (In)	N/A
No	Refuge 1 Slope (%)	8.8	N/A	Gutter 1 Slope (%)	N/A
Yes	Refuge 1 X Slope (%)	1.0	N/A	Gutter 1 X Slope (%)	N/A
N/A	Painted X Walk1?	No	N/A	DWS 1 Provided?	N/A
N/A	X Walk 1 Direction	To S	N/A	DWS 1 Contrast?	N/A
N/A	X Walk 1 Width (In)	N/A	N/A	DWS 1 Length (In)	N/A
N/A	Road 1 Slope (%)	0.1	N/A	DWS 1 Full Width?	N/A
N/A	Road 1 X Slope (%)	9.1	N/A	DWS 1 Offset (In)	N/A
Yes	Refuge 2 Length (In)	61.0	N/A	Gutter 2 Ponding?	N/A
Yes	Refuge 2 Width (In)	124.0	N/A	Gutter 2 Lip Ht (In)	N/A
Yes	Refuge 2 Slope (%)	1.6	N/A	Gutter 2 Slope (%)	N/A
Yes	Refuge 2 X Slope (%)	0.2	N/A	Gutter 2 X Slope (%)	N/A
N/A	Painted X Walk2?	No	N/A	DWS 2 Provided?	N/A
N/A	X Walk 2 Direction	To N	N/A	DWS 2 Contrast?	N/A
N/A	X Walk 2 Width (In)	N/A	N/A	DWS 2 Length (In)	N/A

N/A	Road 2 Slope (%)	0.1	N/A	DWS 2 Full Width?	N/A
N/A	Road 2 X Slope (%)	4.6	N/A	DWS 2 Offset (In)	N/A
N/A	Refuge 3 Length (in)	N/A	N/A	Gutter 3 Ponding?	N/A
N/A	Refuge 3 Width (in)	N/A	N/A	Gutter 3 Lip Ht (in)	N/A
N/A	Refuge 3 Slope (%)	N/A	N/A	Gutter 3 Slope (%)	N/A
N/A	Refuge 3 XSlope (%)	N/A	N/A	Gutter 3 XSlope (%)	N/A
N/A	Painted X Walk3?	N/A	N/A	DWS 3 Provided?	N/A
N/A	X Walk 3 Direction	N/A	N/A	DWS 3 Contrast?	N/A
N/A	X Walk 3 Width (in)	N/A	N/A	DWS 3 Length (in)	N/A
N/A	Road 3 Slope (%)	N/A	N/A	DWS 3 Full Width?	N/A
N/A	Road 3 XSlope (%)	N/A	N/A	DWS 3 Offset (in)	N/A
Yes	Any Obstructions?	N/A	N/A	Storm Grate/Utility Hazard?	N/A
N/A	Obstruction Type		N/A	Storm Grate/Utility Type	
		N/A			N/A
N/A	Surface Condition	Good

Possible Solutions:

Remove & Replace Entire Refuge.
