Access Compliance Report

Public Rights-of-Way

(Island Curb Cuts)

Intersection ID: 42582	Main Street: COLLEGE-TRYON_ST	Cross Street: N_TRYON_ST	Location: W
ADA ID: 1D946A625AC8	Curb Cut Type: MedianRefuge2	Initial Pass/Fail: Fail	Overall Compliance: No
Severity Score: 25			
Codes/Mitigation Info/Possible Solution		Field Measurements/Component Compliance

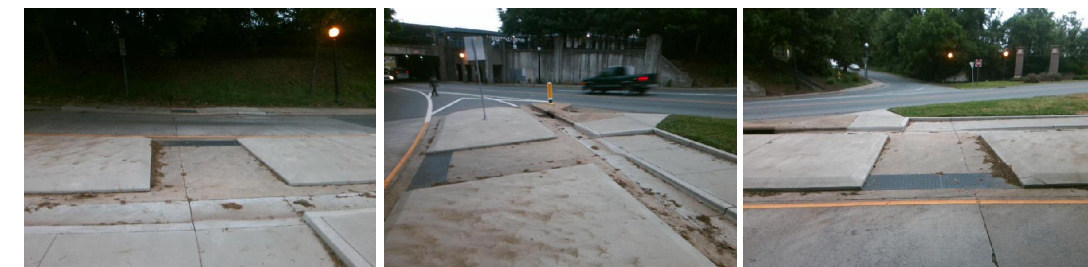
Compliance	Description	Data	Compliance	Description	Data
No	Refuge 1 Length (In)	66.0	N/A	Gutter 1 Ponding?	N/A
Yes	Refuge 1 Width (In)	96.0	N/A	Gutter 1 Lip Ht (In)	N/A
No	Refuge 1 Slope (%)	5.7	N/A	Gutter 1 Slope (%)	N/A
No	Refuge 1 X Slope (%)	6.2	N/A	Gutter 1 X Slope (%)	N/A
N/A	Painted X Walk1?	No	N/A	DWS 1 Provided?	N/A
N/A	X Walk 1 Direction	To NW	N/A	DWS 1 Contrast?	N/A
N/A	X Walk 1 Width (In)	N/A	N/A	DWS 1 Length (In)	N/A
N/A	Road 1 Slope (%)	7.1	N/A	DWS 1 Full Width?	N/A
N/A	Road 1 X Slope (%)	5.6	N/A	DWS 1 Offset (In)	N/A
No	Refuge 2 Length (In)	N/A	N/A	Gutter 2 Ponding?	N/A
Yes	Refuge 2 Width (In)	N/A	N/A	Gutter 2 Lip Ht (In)	N/A
No	Refuge 2 Slope (%)	N/A	N/A	Gutter 2 Slope (%)	N/A
No	Refuge 2 X Slope (%)	N/A	N/A	Gutter 2 X Slope (%)	N/A
N/A	Painted X Walk2?	N/A	N/A	DWS 2 Provided?	N/A
N/A	X Walk 2 Direction	N/A	N/A	DWS 2 Contrast?	N/A
N/A	X Walk 2 Width (In)	N/A	N/A	DWS 2 Length (In)	N/A
N/A	Road 2 Slope (%)	N/A	N/A	DWS 2 Full Width?	N/A

N/A	Road 2 X Slope (%)	N/A	N/A	DWS 2 Offset (In)	N/A
N/A	Refuge 3 Length (in)	N/A	N/A	Gutter 3 Ponding?	N/A
N/A	Refuge 3 Width (in)	N/A	N/A	Gutter 3 Lip Ht (in)	N/A
N/A	Refuge 3 Slope (%)	N/A	N/A	Gutter 3 Slope (%)	N/A
N/A	Refuge 3 XSlope (%)	N/A	N/A	Gutter 3 XSlope (%)	N/A
N/A	Painted X Walk3?	N/A	N/A	DWS 3 Provided?	N/A
N/A	X Walk 3 Direction	N/A	N/A	DWS 3 Contrast?	N/A
N/A	X Walk 3 Width (in)	N/A	N/A	DWS 3 Length (in)	N/A
N/A	Road 3 Slope (%)	N/A	N/A	DWS 3 Full Width?	N/A
N/A	Road 3 XSlope (%)	N/A	N/A	DWS 3 Offset (in)	N/A
Yes	Any Obstructions?	N/A	N/A	Storm Grate/Utility Hazard?	N/A
N/A	Obstruction Type		N/A	Storm Grate/Utility Type	
		N/A			N/A
N/A	Surface Condition	Good

Remove & Replace Entire Refuge.
