Access Compliance Report

Public Rights-of-Way

(Island Curb Cuts)

| Intersection ID: 10029218 | Main Street: JOHNSON AND WALES_WY | Cross Street: N/A | Location: N |

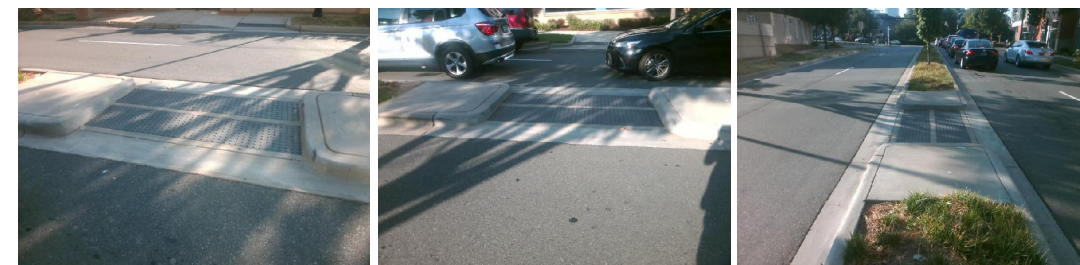
| ADA ID: 1F0AD2B08013 | Curb Cut Type: MedianRefuge2 | Initial Pass/Fail: Fail | Overall Compliance: No |

| Compliance | Description | Data | Compliance | Description | Data |
|---|---|---|---|---|---|
| No | Refuge 1 Length (In) | 30.0 | N/A | Gutter 1 Ponding? | N/A |
| No | Refuge 2 Length (In) | 30.0 | N/A | Gutter 2 Ponding? | N/A |

Remove & Replace Entire Refuge.
