Access Compliance Report

Public Rights-of-Way

(Island Curb Cuts)

Intersection ID: 52494	Main Street: WEST_BV	Cross Street: NEW_RENAISSANCE_WY	Location: NE
ADA ID: 1FBDAE4EF379	Curb Cut Type: MedianRefuge2	Initial Pass/Fail: Fail	Overall Compliance: No
Severity Score: 1.25			
Codes/Mitigation Info/Possible Solution		Field Measurements/Component Compliance

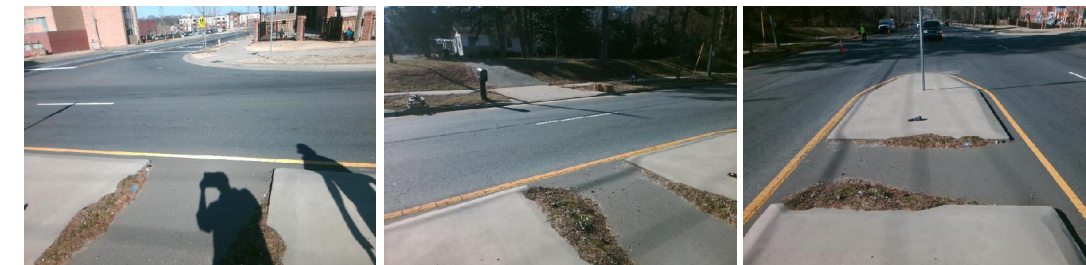
Compliance	Description	Data	Compliance	Description	Data
Yes	Refuge 1 Length (In)	60.0	N/A	Gutter 1 Ponding?	N/A
Yes	Refuge 1 Width (In)	72.0	N/A	Gutter 1 Lip Ht (In)	N/A
Yes	Refuge 1 Slope (%)	2.6	N/A	Gutter 1 Slope (%)	N/A
Yes	Refuge 1 X Slope (%)	3.6	N/A	Gutter 1 X Slope (%)	N/A
N/A	Painted X Walk1?	No	N/A	DWS 1 Provided?	N/A
N/A	X Walk 1 Direction	To NW	N/A	DWS 1 Contrast?	N/A
N/A	X Walk 1 Width (In)	N/A	N/A	DWS 1 Length (In)	N/A
N/A	Road 1 Slope (%)	3.3	N/A	DWS 1 Full Width?	N/A
N/A	Road 1 X Slope (%)	3.1	N/A	DWS 1 Offset (In)	N/A
Yes	Refuge 2 Length (In)	60.0	N/A	Gutter 2 Ponding?	N/A
Yes	Refuge 2 Width (In)	72.0	N/A	Gutter 2 Lip Ht (In)	N/A
Yes	Refuge 2 Slope (%)	1.7	N/A	Gutter 2 Slope (%)	N/A
Yes	Refuge 2 X Slope (%)	3.7	N/A	Gutter 2 X Slope (%)	N/A
N/A	Painted X Walk2?	No	N/A	DWS 2 Provided?	N/A
N/A	X Walk 2 Direction	To SE	N/A	DWS 2 Contrast?	N/A
N/A	X Walk 2 Width (In)	N/A	N/A	DWS 2 Length (In)	N/A

N/A	Road 2 Slope (%)	2.4	N/A	DWS 2 Full Width?	N/A
N/A	Road 2 X Slope (%)	2.6	N/A	DWS 2 Offset (In)	N/A
N/A	Refuge 3 Length (in)	N/A	N/A	Gutter 3 Ponding?	N/A
N/A	Refuge 3 Width (in)	N/A	N/A	Gutter 3 Lip Ht (in)	N/A
N/A	Refuge 3 Slope (%)	N/A	N/A	Gutter 3 Slope (%)	N/A
N/A	Refuge 3 XSlope (%)	N/A	N/A	Gutter 3 XSlope (%)	N/A
N/A	Painted X Walk3?	N/A	N/A	DWS 3 Provided?	N/A
N/A	X Walk 3 Direction	N/A	N/A	DWS 3 Contrast?	N/A
N/A	X Walk 3 Width (in)	N/A	N/A	DWS 3 Length (in)	N/A
N/A	Road 3 Slope (%)	N/A	N/A	DWS 3 Full Width?	N/A
N/A	Road 3 XSlope (%)	N/A	N/A	DWS 3 Offset (in)	N/A
Yes	Any Obstructions?	N/A	N/A	Storm Grate/Utility Hazard?	N/A
N/A	Obstruction Type		N/A	Storm Grate/Utility Type	
		N/A			N/A
N/A	Surface Condition	Good

Possible Solutions:

Remove & Replace Entire Refuge.
