Access Compliance Report

Public Rights-of-Way

(Island Curb Cuts)

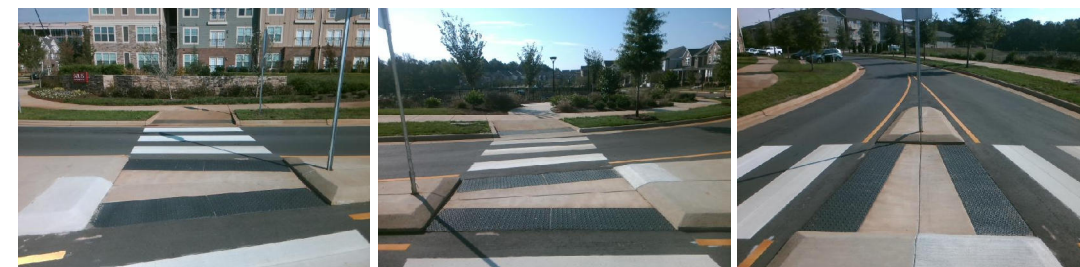
Intersection ID: 53488	Main Street: WAVERLY_WALK_AV	Cross Street: MATTHEWS FARM LN	Location: E
ADA ID: 21453C56506D	Curb Cut Type: MedianRefuge2	Initial Pass/Fail: Fail	Overall Compliance: No
Severity Score: 1.25			
Codes/Mitigation Info/Possible Solution		Field Measurements/Component Compliance

Remove & Replace Entire Refuge.
