Access Compliance Report

Public Rights-of-Way

(Island Curb Cuts)

Intersection ID: 7031	Main Street: BROOKSHIRE_BV	Cross Street: OAKDALE_RD	Location: NE
ADA ID: 216FE7809379	Curb Cut Type: MedianRefuge2	Initial Pass/Fail: Fail	Overall Compliance: No
Codes/Mitigation Info/Possible Solution		Field Measurements/Component Compliance	
Severity Score: 0

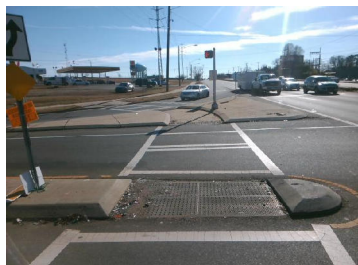
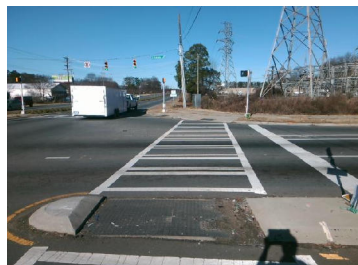
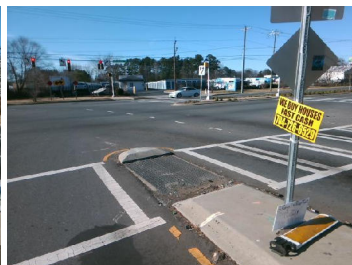
Compliance	Description	Data	Compliance	Description	Data
No	Refuge 1 Length (In)	25.0	N/A	Gutter 1 Ponding?	N/A
Yes	Refuge 1 Width (In)	96.0	N/A	Gutter 1 Lip Ht (In)	N/A
Yes	Refuge 1 Slope (%)	0.9	N/A	Gutter 1 Slope (%)	N/A
Yes	Refuge 1 X Slope (%)	2.6	N/A	Gutter 1 X Slope (%)	N/A
N/A	Painted X Walk1?	Yes	N/A	DWS 1 Provided?	N/A
N/A	X Walk 1 Direction	To SE	N/A	DWS 1 Contrast?	N/A
N/A	X Walk 1 Width (In)	111.0	N/A	DWS 1 Length (In)	N/A
N/A	Road 1 Slope (%)	1.7	N/A	DWS 1 Full Width?	N/A
N/A	Road 1 X Slope (%)	1.2	N/A	DWS 1 Offset (In)	N/A
No	Refuge 2 Length (In)	25.0	N/A	Gutter 2 Ponding?	N/A
Yes	Refuge 2 Width (In)	96.0	N/A	Gutter 2 Lip Ht (In)	N/A
Yes	Refuge 2 Slope (%)	0.4	N/A	Gutter 2 Slope (%)	N/A
Yes	Refuge 2 X Slope (%)	1.6	N/A	Gutter 2 X Slope (%)	N/A
N/A	Painted X Walk2?	Yes	N/A	DWS 2 Provided?	N/A
N/A	X Walk 2 Direction	To NW	N/A	DWS 2 Contrast?	N/A
N/A	X Walk 2 Width (In)	113.0	N/A	DWS 2 Length (In)	N/A

Remove & Replace Entire Refuge.
