Access Compliance Report

Public Rights-of-Way

(Island Curb Cuts)

Intersection ID: 6102	Main Street: UNIVERSITY_CITY_BV	Cross Street: UNIVERSITY_PROFESSIONAL_DR	Location: W
ADA ID: 218D6FF2FAE1	Curb Cut Type: MedianRefuge2	Initial Pass/Fail: Pass	Overall Compliance: No
Codes/Mitigation Info/Possible Solution		Field Measurements/Component Compliance

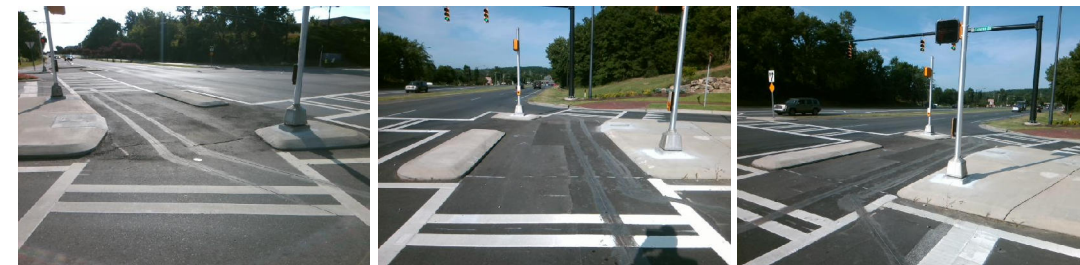
Compliance	Description	Data	Compliance	Description	Data
Yes	Refuge 1 Length (In)	114.0	N/A	Gutter 1 Ponding?	No
Yes	Refuge 1 Width (In)	120.0	N/A	Gutter 1 Lip Ht (In)	N/A
Yes	Refuge 1 Slope (%)	1.3	N/A	Gutter 1 Slope (%)	N/A
Yes	Refuge 1 X Slope (%)	0.6	N/A	Gutter 1 X Slope (%)	N/A
N/A	Painted X Walk1?	Yes	No	DWS 1 Provided?	No
N/A	X Walk 1 Direction	To W	N/A	DWS 1 Contrast?	No
N/A	X Walk 1 Width (In)	119.0	N/A	DWS 1 Length (In)	N/A
N/A	Road 1 Slope (%)	0.6	N/A	DWS 1 Full Width?	No
N/A	Road 1 X Slope (%)	1.3	N/A	DWS 1 Offset (In)	N/A
Yes	Refuge 2 Length (In)	114.0	N/A	Gutter 2 Ponding?	No
Yes	Refuge 2 Width (In)	120.0	N/A	Gutter 2 Lip Ht (In)	N/A
Yes	Refuge 2 Slope (%)	4.2	N/A	Gutter 2 Slope (%)	N/A
Yes	Refuge 2 X Slope (%)	0.1	N/A	Gutter 2 X Slope (%)	N/A
N/A	Painted X Walk2?	Yes	No	DWS 2 Provided?	No
N/A	X Walk 2 Direction	To E	N/A	DWS 2 Contrast?	No
N/A	X Walk 2 Width (In)	115.0	N/A	DWS 2 Length (In)	N/A

N/A	Road 2 Slope (%)	0.1	N/A	DWS 2 Full Width?	No
N/A	Road 2 X Slope (%)	4.3	N/A	DWS 2 Offset (In)	N/A
N/A	Refuge 3 Length (in)	N/A	N/A	Gutter 3 Ponding?	No
N/A	Refuge 3 Width (in)	N/A	N/A	Gutter 3 Lip Ht (in)	N/A
N/A	Refuge 3 Slope (%)	N/A	N/A	Gutter 3 Slope (%)	N/A
N/A	Refuge 3 XSlope (%)	N/A	N/A	Gutter 3 XSlope (%)	N/A
N/A	Painted X Walk3?	No	N/A	DWS 3 Provided?	N/A
N/A	X Walk 3 Direction	N/A	N/A	DWS 3 Contrast?	N/A
N/A	X Walk 3 Width (in)	N/A	N/A	DWS 3 Length (in)	N/A
N/A	Road 3 Slope (%)	N/A	N/A	DWS 3 Full Width?	N/A
N/A	Road 3 XSlope (%)	N/A	N/A	DWS 3 Offset (in)	N/A
Yes	Any Obstructions?	No	N/A	Storm Grate/Utility Hazard?	No
N/A	Obstruction Type		N/A	Storm Grate/Utility Type	
		N/A			N/A
N/A	Surface Condition	Good

Install Detectable Warning System.
