Access Compliance Report

Public Rights-of-Way

(Island Curb Cuts)

Intersection ID: 10040110	Main Street: TUCKASEEGEE_RD	Cross Street: N/A	Location: S
ADA ID: 2891EA0A3EF6	Curb Cut Type: MedianRefuge2	Initial Pass/Fail: Fail	Overall Compliance: No
			Severity Score: 1.25

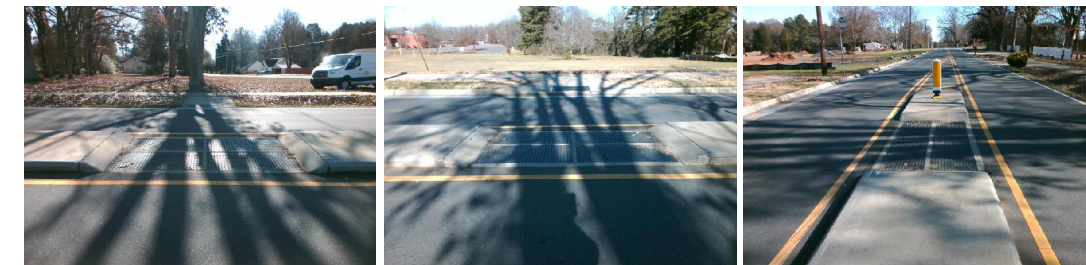
Compliance	Description	Data	Compliance	Description	Data
No	Refuge 1 Length (In)	30.0	N/A	Gutter 1 Ponding?	N/A
Yes	Refuge 1 Width (In)	96.0	N/A	Gutter 1 Lip Ht (In)	N/A
Yes	Refuge 1 Slope (%)	1.5	N/A	Gutter 1 Slope (%)	N/A
Yes	Refuge 1 X Slope (%)	0.0	N/A	Gutter 1 X Slope (%)	N/A
N/A	Painted X Walk1?	No	N/A	DWS 1 Provided?	N/A
N/A	X Walk 1 Direction	To S	N/A	DWS 1 Contrast?	N/A
N/A	X Walk 1 Width (In)	N/A	N/A	DWS 1 Length (In)	N/A
N/A	Road 1 Slope (%)	1.0	N/A	DWS 1 Full Width?	N/A
N/A	Road 1 X Slope (%)	0.4	N/A	DWS 1 Offset (In)	N/A
No	Refuge 2 Length (In)	30.0	N/A	Gutter 2 Ponding?	N/A
Yes	Refuge 2 Width (In)	96.0	N/A	Gutter 2 Lip Ht (In)	N/A
Yes	Refuge 2 Slope (%)	4.8	N/A	Gutter 2 Slope (%)	N/A
Yes	Refuge 2 X Slope (%)	2.1	N/A	Gutter 2 X Slope (%)	N/A
N/A	Painted X Walk2?	No	N/A	DWS 2 Provided?	N/A
N/A	X Walk 2 Direction	To N	N/A	DWS 2 Contrast?	N/A
N/A	X Walk 2 Width (In)	N/A	N/A	DWS 2 Length (In)	N/A

N/A	Road 2 Slope (%)	1.0	N/A	DWS 2 Full Width?	N/A
N/A	Road 2 X Slope (%)	3.9	N/A	DWS 2 Offset (In)	N/A
N/A	Refuge 3 Length (in)	N/A	N/A	Gutter 3 Ponding?	N/A
N/A	Refuge 3 Width (in)	N/A	N/A	Gutter 3 Lip Ht (in)	N/A
N/A	Refuge 3 Slope (%)	N/A	N/A	Gutter 3 Slope (%)	N/A
N/A	Refuge 3 XSlope (%)	N/A	N/A	Gutter 3 XSlope (%)	N/A
N/A	Painted X Walk3?	N/A	N/A	DWS 3 Provided?	N/A
N/A	X Walk 3 Direction	N/A	N/A	DWS 3 Contrast?	N/A
N/A	X Walk 3 Width (in)	N/A	N/A	DWS 3 Length (in)	N/A
N/A	Road 3 Slope (%)	N/A	N/A	DWS 3 Full Width?	N/A
N/A	Road 3 XSlope (%)	N/A	N/A	DWS 3 Offset (in)	N/A
Yes	Any Obstructions?	N/A	N/A	Storm Grate/Utility Hazard?	N/A
N/A	Obstruction Type		N/A	Storm Grate/Utility Type	
		N/A			N/A
N/A	Surface Condition	Good

Remove & Replace Entire Refuge.
