Access Compliance Report

Public Rights-of-Way

(Island Curb Cuts)

Intersection ID: 11208	Main Street: PARKWOOD_AV	Cross Street: N_BREVARD_ST	Location: E
ADA ID: 28F51DAEE08D	Curb Cut Type: MedianRefuge2	Initial Pass/Fail: Pass	Overall Compliance: No
Severity Score: 10.25			
Codes/Mitigation Info/Possible Solution		Field Measurements/Component Compliance

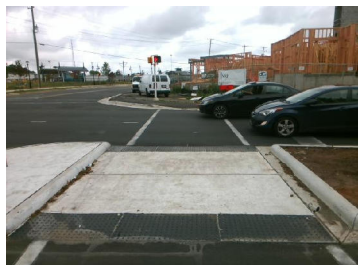
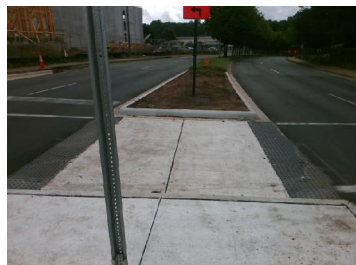
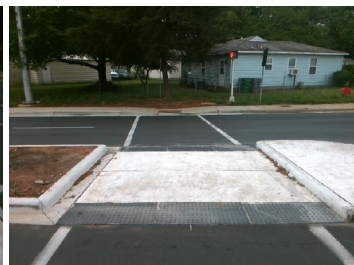
Compliance	Description	Data	Compliance	Description	Data
Yes	Refuge 1 Length (In)	80.0	Yes	Gutter 1 Ponding?	No
Yes	Refuge 1 Width (In)	143.0	Yes	Gutter 1 Lip Ht (In)	0.0
Yes	Refuge 1 Slope (%)	2.0	No	Gutter 1 Slope (%)	5.4
Yes	Refuge 1 X Slope (%)	0.5	Yes	Gutter 1 X Slope (%)	0.1
N/A	Painted X Walk1?	Yes	Yes	DWS 1 Provided?	Yes
N/A	X Walk 1 Direction	To N	Yes	DWS 1 Contrast?	Yes
N/A	X Walk 1 Width (In)	113.0	No	DWS 1 Length (In)	23.0
N/A	Road 1 Slope (%)	0.4	Yes	DWS 1 Full Width?	Yes
N/A	Road 1 X Slope (%)	4.3	Yes	DWS 1 Offset (In)	0.0
Yes	Refuge 2 Length (In)	82.0	Yes	Gutter 2 Ponding?	No
Yes	Refuge 2 Width (In)	143.0	Yes	Gutter 2 Lip Ht (In)	0.0
Yes	Refuge 2 Slope (%)	3.7	Yes	Gutter 2 Slope (%)	3.0
Yes	Refuge 2 X Slope (%)	0.1	Yes	Gutter 2 X Slope (%)	0.7
N/A	Painted X Walk2?	Yes	Yes	DWS 2 Provided?	Yes
N/A	X Walk 2 Direction	To S	Yes	DWS 2 Contrast?	Yes
N/A	X Walk 2 Width (In)	115.0	No	DWS 2 Length (In)	23.5

N/A	Road 2 Slope (%)	0.9	Yes	DWS 2 Full Width?	Yes
N/A	Road 2 X Slope (%)	2.9	Yes	DWS 2 Offset (In)	0.0
N/A	Refuge 3 Length (in)	N/A	N/A	Gutter 3 Ponding?	N/A
N/A	Refuge 3 Width (in)	N/A	N/A	Gutter 3 Lip Ht (in)	N/A
N/A	Refuge 3 Slope (%)	N/A	N/A	Gutter 3 Slope (%)	N/A
N/A	Refuge 3 XSlope (%)	N/A	N/A	Gutter 3 XSlope (%)	N/A
N/A	Painted X Walk3?	N/A	N/A	DWS 3 Provided?	N/A
N/A	X Walk 3 Direction	N/A	N/A	DWS 3 Contrast?	N/A
N/A	X Walk 3 Width (in)	N/A	N/A	DWS 3 Length (in)	N/A
N/A	Road 3 Slope (%)	N/A	N/A	DWS 3 Full Width?	N/A
N/A	Road 3 XSlope (%)	N/A	N/A	DWS 3 Offset (in)	N/A
Yes	Any Obstructions?	No	N/A	Storm Grate/Utility Hazard?	No
N/A	Obstruction Type		N/A	Storm Grate/Utility Type	
		N/A			N/A
N/A	Surface Condition	Good

Possible Solutions:

Remove & Replace Detectable Warning System. Remove & Replace Gutter.
