Access Compliance Report

Public Rights-of-Way

(Island Curb Cuts)

Intersection ID: 51379	Main Street: BROADRICK_BV	Cross Street: UNIVERSITY_CITY_BV	Location: E
ADA ID: 294ADA3F59A8	Curb Cut Type: MedianRefuge2	Initial Pass/Fail: Pass	Overall Compliance: No
Severity Score: 5.25			
Codes/Mitigation Info/Possible Solution		Field Measurements/Component Compliance

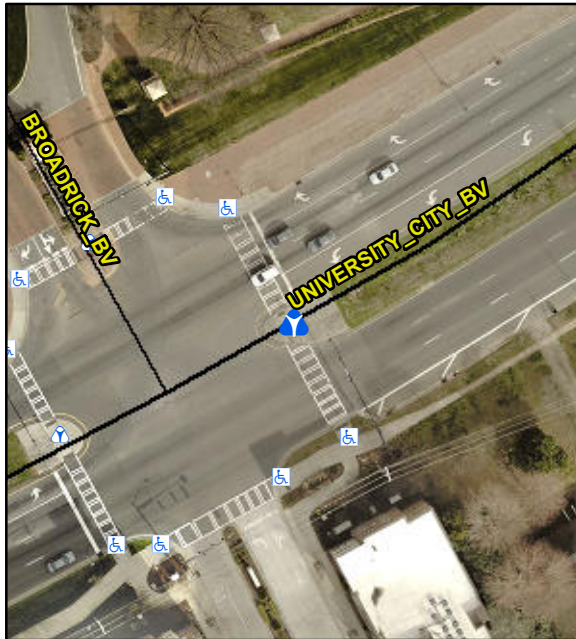
N/A	Road 2 Slope (%)	0.1	No	DWS 2 Full Width?	No
N/A	Road 2 X Slope (%)	1.3	No	DWS 2 Offset (In)	25.0
N/A	Refuge 3 Length (in)	N/A	N/A	Gutter 3 Ponding?	No
N/A	Refuge 3 Width (in)	N/A	N/A	Gutter 3 Lip Ht (in)	0.0
N/A	Refuge 3 Slope (%)	N/A	N/A	Gutter 3 Slope (%)	N/A
N/A	Refuge 3 XSlope (%)	N/A	N/A	Gutter 3 XSlope (%)	N/A
N/A	Painted X Walk3?	No	N/A	DWS 3 Provided?	N/A
N/A	X Walk 3 Direction	N/A	N/A	DWS 3 Contrast?	N/A
N/A	X Walk 3 Width (in)	N/A	N/A	DWS 3 Length (in)	N/A
N/A	Road 3 Slope (%)	N/A	N/A	DWS 3 Full Width?	N/A
N/A	Road 3 XSlope (%)	N/A	N/A	DWS 3 Offset (in)	N/A
Yes	Any Obstructions?	No	N/A	Storm Grate/Utility Hazard?	No
N/A	Obstruction Type		N/A	Storm Grate/Utility Type	
		N/A			N/A
N/A	Surface Condition	Good

Possible Solutions:

Remove & Replace Detectable Warning System.
