Access Compliance Report

Public Rights-of-Way

(Island Curb Cuts)

Intersection ID: 53165	Main Street: DIXIE_RIVER_RD	Cross Street: STYLE_LN	Location: S
ADA ID: 2AE565D7629F	Curb Cut Type: MedianRefuge2	Initial Pass/Fail: Fail	Overall Compliance: No
Codes/Mitigation Info/Possible Solution		Field Measurements/Component Compliance

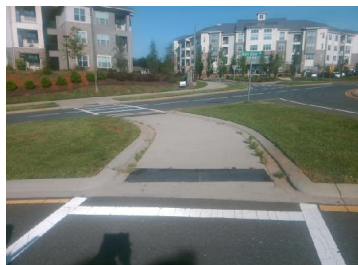
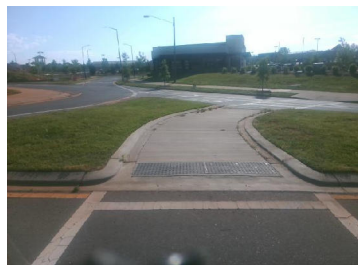
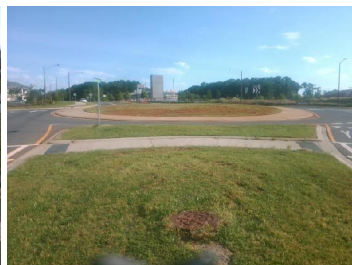
Compliance	Description	Data	Compliance	Description	Data
Yes	Refuge 1 Length (In)	187.5	N/A	Gutter 1 Ponding?	N/A
Yes	Refuge 1 Width (In)	105.5	N/A	Gutter 1 Lip Ht (In)	N/A
Yes	Refuge 1 Slope (%)	1.9	N/A	Gutter 1 Slope (%)	N/A
No	Refuge 1 X Slope (%)	5.1	N/A	Gutter 1 X Slope (%)	N/A
N/A	Painted X Walk1?	Yes	N/A	DWS 1 Provided?	N/A
N/A	X Walk 1 Direction	To SE	N/A	DWS 1 Contrast?	N/A
N/A	X Walk 1 Width (In)	112	N/A	DWS 1 Length (In)	N/A
N/A	Road 1 Slope (%)	2.5	N/A	DWS 1 Full Width?	N/A
N/A	Road 1 X Slope (%)	4.6	N/A	DWS 1 Offset (In)	N/A
Yes	Refuge 2 Length (In)	187.5	N/A	Gutter 2 Ponding?	N/A
Yes	Refuge 2 Width (In)	105.5	N/A	Gutter 2 Lip Ht (In)	N/A
Yes	Refuge 2 Slope (%)	1.3	N/A	Gutter 2 Slope (%)	N/A
Yes	Refuge 2 X Slope (%)	0.1	N/A	Gutter 2 X Slope (%)	N/A
N/A	Painted X Walk2?	Yes	N/A	DWS 2 Provided?	N/A
N/A	X Walk 2 Direction	To W	N/A	DWS 2 Contrast?	N/A
N/A	X Walk 2 Width (In)	112	N/A	DWS 2 Length (In)	N/A

Remove & Replace Entire Refuge.
