Access Compliance Report

Public Rights-of-Way

(Island Curb Cuts)

Intersection ID: 52790	Main Street: COLEMON_KERRY_DR	Cross Street: FRIENDSHIP_VILLAGE_PL	Location: S
ADA ID: 2B7A9A3A9295	Curb Cut Type: MedianRefuge2	Initial Pass/Fail: Pass	Overall Compliance: No
Severity Score: 15.25			
Codes/Mitigation Info/Possible Solution		Field Measurements/Component Compliance

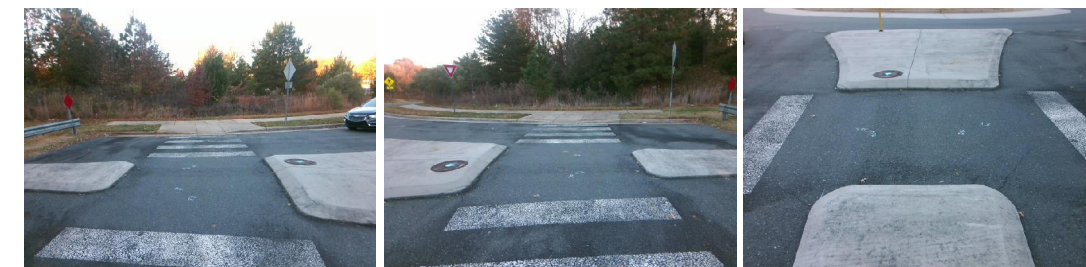
Compliance	Description	Data	Compliance	Description	Data
No	Refuge 1 Length (In)	35.5	Yes	Gutter 1 Ponding?	No
Yes	Refuge 1 Width (In)	120.0	Yes	Gutter 1 Lip Ht (In)	0.0
Yes	Refuge 1 Slope (%)	3.6	No	Gutter 1 Slope (%)	N/A
Yes	Refuge 1 X Slope (%)	0.7	No	Gutter 1 X Slope (%)	N/A
N/A	Painted X Walk1?	No	Yes	DWS 1 Provided?	No
N/A	X Walk 1 Direction	To W	N/A	DWS 1 Contrast?	No
N/A	X Walk 1 Width (In)	N/A	N/A	DWS 1 Length (In)	N/A
N/A	Road 1 Slope (%)	1.0	N/A	DWS 1 Full Width?	No
N/A	Road 1 X Slope (%)	3.1	N/A	DWS 1 Offset (In)	N/A
No	Refuge 2 Length (In)	35.5	N/A	Gutter 2 Ponding?	No
Yes	Refuge 2 Width (In)	120.0	N/A	Gutter 2 Lip Ht (In)	N/A
Yes	Refuge 2 Slope (%)	1.3	N/A	Gutter 2 Slope (%)	N/A
Yes	Refuge 2 X Slope (%)	0.4	N/A	Gutter 2 X Slope (%)	N/A
N/A	Painted X Walk2?	No	Yes	DWS 2 Provided?	No
N/A	X Walk 2 Direction	To E	N/A	DWS 2 Contrast?	No
N/A	X Walk 2 Width (In)	N/A	N/A	DWS 2 Length (In)	N/A
N/A	Road 2 Slope (%)	0.8	N/A	DWS 2 Full Width?	No

N/A	Road 2 X Slope (%)	2.0	N/A	DWS 2 Offset (In)	N/A
N/A	Refuge 3 Length (in)	N/A	N/A	Gutter 3 Ponding?	N/A
N/A	Refuge 3 Width (in)	N/A	N/A	Gutter 3 Lip Ht (in)	N/A
N/A	Refuge 3 Slope (%)	N/A	N/A	Gutter 3 Slope (%)	N/A
N/A	Refuge 3 XSlope (%)	N/A	N/A	Gutter 3 XSlope (%)	N/A
N/A	Painted X Walk3?	N/A	N/A	DWS 3 Provided?	N/A
N/A	X Walk 3 Direction	N/A	N/A	DWS 3 Contrast?	N/A
N/A	X Walk 3 Width (in)	N/A	N/A	DWS 3 Length (in)	N/A
N/A	Road 3 Slope (%)	N/A	N/A	DWS 3 Full Width?	N/A
N/A	Road 3 XSlope (%)	N/A	N/A	DWS 3 Offset (in)	N/A
Yes	Any Obstructions?	No	N/A	Storm Grate/Utility Hazard?	No
N/A	Obstruction Type		N/A	Storm Grate/Utility Type	
		N/A			N/A
N/A	Surface Condition	Good

Remove & Replace Entire Refuge.
Remove & Replace Gutter.
