Access Compliance Report

Public Rights-of-Way

(Island Curb Cuts)

Intersection ID: 53191	Main Street: JOHNSTON_OEHLER_PRIVATE_DR	Cross Street: JOHNSTON_OEHLER_RD	Location: W
ADA ID: 30BB82018E09	Curb Cut Type: MedianRefuge2	Initial Pass/Fail: Fail	Overall Compliance: No
Codes/Mitigation Info/Possible Solution		Field Measurements/Component Compliance	
Severity Score: 12.5

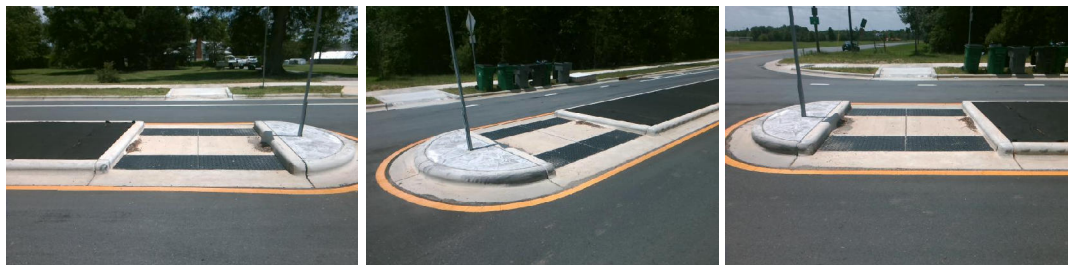
Compliance	Description	Data	Compliance	Description	Data
Yes	Refuge 1 Length (In)	47.5	N/A	Gutter 1 Ponding?	N/A
Yes	Refuge 1 Width (In)	96.0	N/A	Gutter 1 Lip Ht (In)	N/A
No	Refuge 1 Slope (%)	5.9	N/A	Gutter 1 Slope (%)	N/A
Yes	Refuge 1 X Slope (%)	1.0	N/A	Gutter 1 X Slope (%)	N/A
N/A	Painted X Walk1?	No	N/A	DWS 1 Provided?	N/A
N/A	X Walk 1 Direction	To SW	N/A	DWS 1 Contrast?	N/A
N/A	X Walk 1 Width (In)	N/A	N/A	DWS 1 Length (In)	N/A
N/A	Road 1 Slope (%)	0.9	N/A	DWS 1 Full Width?	N/A
N/A	Road 1 X Slope (%)	2.4	N/A	DWS 1 Offset (In)	N/A
Yes	Refuge 2 Length (In)	47.5	N/A	Gutter 2 Ponding?	N/A
Yes	Refuge 2 Width (In)	96.0	N/A	Gutter 2 Lip Ht (In)	N/A
No	Refuge 2 Slope (%)	5.4	N/A	Gutter 2 Slope (%)	N/A
Yes	Refuge 2 X Slope (%)	1.5	N/A	Gutter 2 X Slope (%)	N/A
N/A	Painted X Walk2?	No	N/A	DWS 2 Provided?	N/A
N/A	X Walk 2 Direction	To NE	N/A	DWS 2 Contrast?	N/A
N/A	X Walk 2 Width (In)	N/A	N/A	DWS 2 Length (In)	N/A

Remove & Replace Entire Refuge.
