Access Compliance Report

Public Rights-of-Way

(Island Curb Cuts)

Intersection ID: 10015853	Main Street: STATESVILLE_AV	Cross Street: N/A	Location: N
ADA ID: 31B753864CA8	Curb Cut Type: MedianRefuge2	Initial Pass/Fail: Pass	Overall Compliance: No
Codes/Mitigation Info/Possible Solution		Field Measurements/Component Compliance

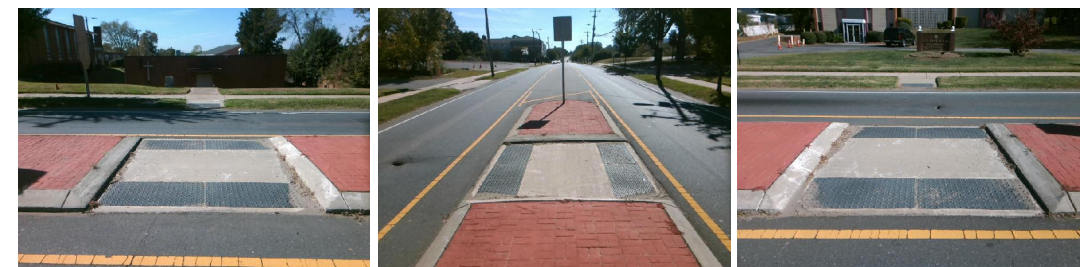
Compliance	Description	Data	Compliance	Description	Data
Yes	Refuge 1 Length (In)	54.0	Yes	Gutter 1 Ponding?	No
Yes	Refuge 1 Width (In)	99.0	No	Gutter 1 Lip Ht (In)	0.5
Yes	Refuge 1 Slope (%)	1.5	No	Gutter 1 Slope (%)	8.0
Yes	Refuge 1 X Slope (%)	0.2	Yes	Gutter 1 X Slope (%)	1.4
N/A	Painted X Walk1?	No	Yes	DWS 1 Provided?	Yes
N/A	X Walk 1 Direction	To W	Yes	DWS 1 Contrast?	Yes
N/A	X Walk 1 Width (In)	N/A	Yes	DWS 1 Length (In)	24.0
N/A	Road 1 Slope (%)	0.6	Yes	DWS 1 Full Width?	Yes
N/A	Road 1 X Slope (%)	3.8	No	DWS 1 Offset (In)	4.5
Yes	Refuge 2 Length (In)	54.0	Yes	Gutter 2 Ponding?	No
Yes	Refuge 2 Width (In)	99.0	Yes	Gutter 2 Lip Ht (In)	0.0
Yes	Refuge 2 Slope (%)	2.2	Yes	Gutter 2 Slope (%)	0.2
Yes	Refuge 2 X Slope (%)	1.8	No	Gutter 2 X Slope (%)	5.7
N/A	Painted X Walk2?	No	Yes	DWS 2 Provided?	Yes
N/A	X Walk 2 Direction	To E	Yes	DWS 2 Contrast?	Yes
N/A	X Walk 2 Width (In)	N/A	Yes	DWS 2 Length (In)	24.0
N/A	Road 2 Slope (%)	0.8	Yes	DWS 2 Full Width?	Yes

N/A	Road 2 X Slope (%)	5.6	No	DWS 2 Offset (In)	4.5
N/A	Refuge 3 Length (in)	N/A	N/A	Gutter 3 Ponding?	N/A
N/A	Refuge 3 Width (in)	N/A	N/A	Gutter 3 Lip Ht (in)	N/A
N/A	Refuge 3 Slope (%)	N/A	N/A	Gutter 3 Slope (%)	N/A
N/A	Refuge 3 XSlope (%)	N/A	N/A	Gutter 3 XSlope (%)	N/A
N/A	Painted X Walk3?	N/A	N/A	DWS 3 Provided?	N/A
N/A	X Walk 3 Direction	N/A	N/A	DWS 3 Contrast?	N/A
N/A	X Walk 3 Width (in)	N/A	N/A	DWS 3 Length (in)	N/A
N/A	Road 3 Slope (%)	N/A	N/A	DWS 3 Full Width?	N/A
N/A	Road 3 XSlope (%)	N/A	N/A	DWS 3 Offset (in)	N/A
Yes	Any Obstructions?	No	N/A	Storm Grate/Utility Hazard?	No
N/A	Obstruction Type		N/A	Storm Grate/Utility Type	
		N/A			N/A
N/A	Surface Condition	Good

Possible Solutions:

Remove & Replace Detectable Warning System. Remove & Replace Gutter.
