# Access Compliance Report

## Public Rights-of-Way

### (Island Curb Cuts)

| Intersection ID: 11730 | Main Street: MECKLENBURG_AV | Cross Street: THE_PLAZA | Location: NE |

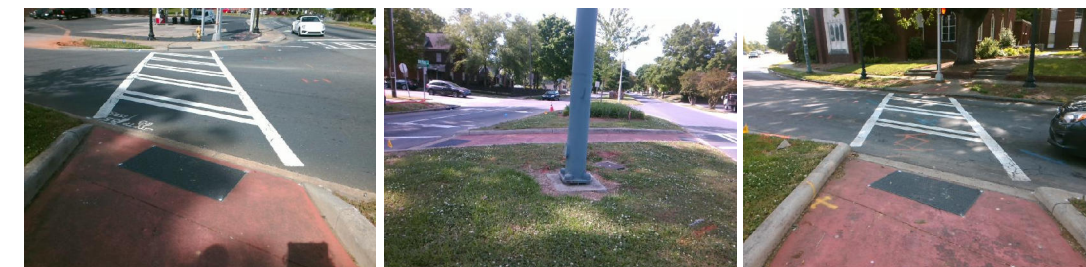
| Compliance | Description | Data | Compliance | Description | Data |
|---|---|---|---|---|---|
| Yes | Refuge 1 Width (In) | 95.0 | No | Gutter 1 Lip Ht (In) | 0.5 |
| N/A | Road 1 Slope (%) | 1.4 | No | DWS 1 Full Width? | No |
| N/A | Road 1 X Slope (%) | 0.4 | No | DWS 1 Offset (In) | 5.0 |
| N/A | Surface Condition | Good | | | |

**Remove & Replace Detectable Warning System. Remove & Replace Gutter.**
