Access Compliance Report

Public Rights-of-Way

(Island Curb Cuts)

Intersection ID: 52765	Main Street: SHOPTON_RD	Cross Street: OUTLETS_BV	Location: S
ADA ID: 368267FD5733	Curb Cut Type: MedianRefuge2	Initial Pass/Fail: Fail	Overall Compliance: No
Codes/Mitigation Info/Possible Solution		Field Measurements/Component Compliance

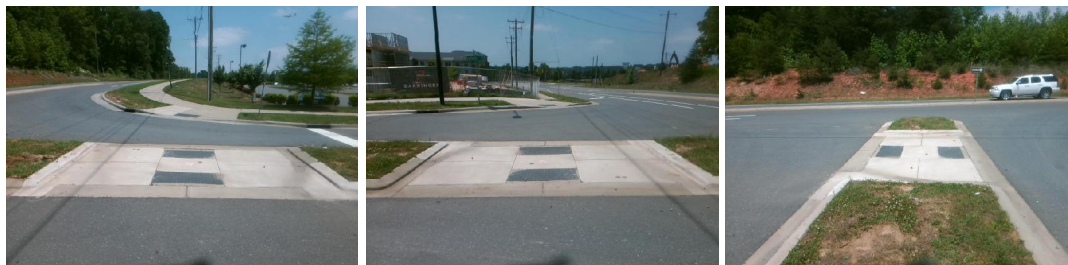
Compliance	Description	Data	Compliance	Description	Data
Yes	Refuge 1 Length (In)	47	N/A	Gutter 1 Ponding?	N/A
No	Refuge 1 Width (In)	47.5	N/A	Gutter 1 Lip Ht (In)	N/A
Yes	Refuge 1 Slope (%)	4.3	N/A	Gutter 1 Slope (%)	N/A
Yes	Refuge 1 X Slope (%)	3.4	N/A	Gutter 1 X Slope (%)	N/A
N/A	Painted X Walk1?	No	N/A	DWS 1 Provided?	N/A
N/A	X Walk 1 Direction	To E	N/A	DWS 1 Contrast?	N/A
N/A	X Walk 1 Width (In)	N/A	N/A	DWS 1 Length (In)	N/A
N/A	Road 1 Slope (%)	4.0	N/A	DWS 1 Full Width?	N/A
N/A	Road 1 X Slope (%)	2.0	N/A	DWS 1 Offset (In)	N/A
Yes	Refuge 2 Length (In)	47	N/A	Gutter 2 Ponding?	N/A
No	Refuge 2 Width (In)	47.5	N/A	Gutter 2 Lip Ht (In)	N/A
Yes	Refuge 2 Slope (%)	0.4	N/A	Gutter 2 Slope (%)	N/A
Yes	Refuge 2 X Slope (%)	3.3	N/A	Gutter 2 X Slope (%)	N/A
N/A	Painted X Walk2?	No	N/A	DWS 2 Provided?	N/A
N/A	X Walk 2 Direction	To W	N/A	DWS 2 Contrast?	N/A
N/A	X Walk 2 Width (In)	N/A	N/A	DWS 2 Length (In)	N/A
N/A	Road 2 Slope (%)	1.7	N/A	DWS 2 Full Width?	N/A

Remove & Replace Entire Refuge.
