Access Compliance Report

Public Rights-of-Way

(Island Curb Cuts)

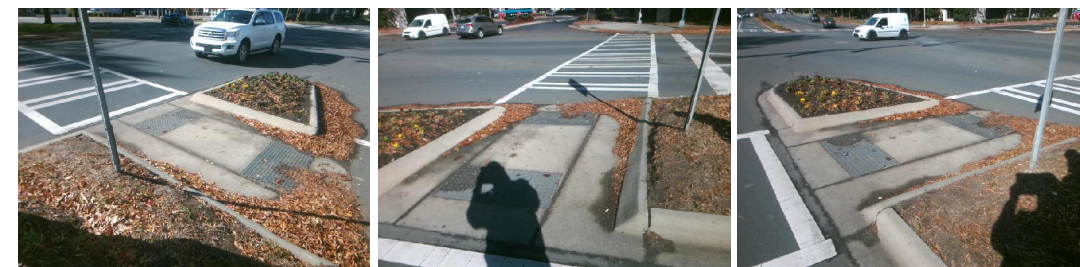
Intersection ID: 20185	Main Street: FAIRVIEW_RD	Cross Street: PIEDMONT_ROW_DR	Location: SE
ADA ID: 3787DB84157B	Curb Cut Type: MedianRefuge2	Initial Pass/Fail: Fail	Overall Compliance: No
Codes/Mitigation Info/Possible Solution		Field Measurements/Component Compliance	
Severity Score: 1.25

Compliance	Description	Data	Compliance	Description	Data
Yes	Refuge 1 Length (In)	56.0	N/A	Gutter 1 Ponding?	N/A
Yes	Refuge 1 Width (In)	90.0	N/A	Gutter 1 Lip Ht (In)	N/A
Yes	Refuge 1 Slope (%)	1.5	N/A	Gutter 1 Slope (%)	N/A
Yes	Refuge 1 X Slope (%)	3.0	N/A	Gutter 1 X Slope (%)	N/A
N/A	Painted X Walk1?	Yes	N/A	DWS 1 Provided?	N/A
N/A	X Walk 1 Direction	To SW	N/A	DWS 1 Contrast?	N/A
N/A	X Walk 1 Width (In)	111.0	N/A	DWS 1 Length (In)	N/A
N/A	Road 1 Slope (%)	2.0	N/A	DWS 1 Full Width?	N/A
N/A	Road 1 X Slope (%)	1.7	N/A	DWS 1 Offset (In)	N/A
Yes	Refuge 2 Length (In)	56.0	N/A	Gutter 2 Ponding?	N/A
Yes	Refuge 2 Width (In)	90.0	N/A	Gutter 2 Lip Ht (In)	N/A
Yes	Refuge 2 Slope (%)	2.2	N/A	Gutter 2 Slope (%)	N/A
Yes	Refuge 2 X Slope (%)	2.2	N/A	Gutter 2 X Slope (%)	N/A
N/A	Painted X Walk2?	Yes	N/A	DWS 2 Provided?	N/A
N/A	X Walk 2 Direction	To NE	N/A	DWS 2 Contrast?	N/A
N/A	X Walk 2 Width (In)	112.0	N/A	DWS 2 Length (In)	N/A

N/A	Road 2 Slope (%)	2.4	N/A	DWS 2 Full Width?	N/A
N/A	Road 2 X Slope (%)	1.1	N/A	DWS 2 Offset (In)	N/A
N/A	Refuge 3 Length (in)	N/A	N/A	Gutter 3 Ponding?	N/A
N/A	Refuge 3 Width (in)	N/A	N/A	Gutter 3 Lip Ht (in)	N/A
N/A	Refuge 3 Slope (%)	N/A	N/A	Gutter 3 Slope (%)	N/A
N/A	Refuge 3 XSlope (%)	N/A	N/A	Gutter 3 XSlope (%)	N/A
N/A	Painted X Walk3?	N/A	N/A	DWS 3 Provided?	N/A
N/A	X Walk 3 Direction	N/A	N/A	DWS 3 Contrast?	N/A
N/A	X Walk 3 Width (in)	N/A	N/A	DWS 3 Length (in)	N/A
N/A	Road 3 Slope (%)	N/A	N/A	DWS 3 Full Width?	N/A
N/A	Road 3 XSlope (%)	N/A	N/A	DWS 3 Offset (in)	N/A
Yes	Any Obstructions?	N/A	N/A	Storm Grate/Utility Hazard?	N/A
N/A	Obstruction Type		N/A	Storm Grate/Utility Type	
		N/A			N/A
N/A	Surface Condition	Good

Possible Solutions:

Remove & Replace Entire Refuge.
