# Access Compliance Report

## Public Rights-of-Way

### (Island Curb Cuts)

Intersection ID: 28304	Main Street: LANCASTER_HY	Cross Street: JOHNSTON_RD	Location: NW
ADA ID: 37E188321F00	Curb Cut Type: MedianRefuge2	Initial Pass/Fail: Pass	Overall Compliance: No
Severity Score: 0.25			
Codes/Mitigation Info/Possible Solution		Field Measurements/Component Compliance

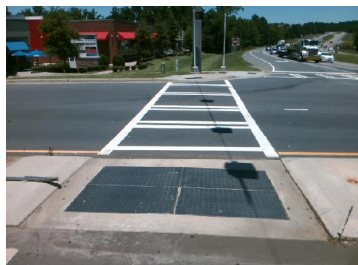
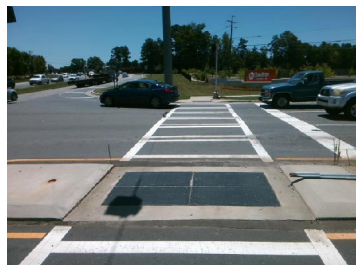
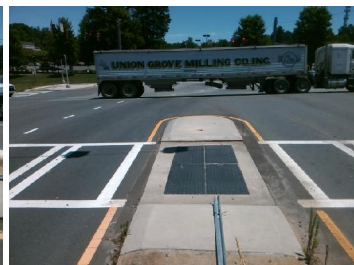
N/A	Road 2 Slope (%)	0.2	Yes	DWS 2 Full Width?	Yes
N/A	Road 2 X Slope (%)	2.9	No	DWS 2 Offset (In)	12.0
N/A	Refuge 3 Length (in)	N/A	N/A	Gutter 3 Ponding?	N/A
N/A	Refuge 3 Width (in)	N/A	N/A	Gutter 3 Lip Ht (in)	N/A
N/A	Refuge 3 Slope (%)	N/A	N/A	Gutter 3 Slope (%)	N/A
N/A	Refuge 3 XSlope (%)	N/A	N/A	Gutter 3 XSlope (%)	N/A
N/A	Painted X Walk3?	N/A	N/A	DWS 3 Provided?	N/A
N/A	X Walk 3 Direction	N/A	N/A	DWS 3 Contrast?	N/A
N/A	X Walk 3 Width (in)	N/A	N/A	DWS 3 Length (in)	N/A
N/A	Road 3 Slope (%)	N/A	N/A	DWS 3 Full Width?	N/A
N/A	Road 3 XSlope (%)	N/A	N/A	DWS 3 Offset (in)	N/A
Yes	Any Obstructions?	N/A	N/A	Storm Grate/Utility Hazard?	No
N/A	Obstruction Type		N/A	Storm Grate/Utility Type	
		N/A			N/A
N/A	Surface Condition	Good

**Remove & Replace Detectable Warning System.**
