# Access Compliance Report

## Public Rights-of-Way

### (Island Curb Cuts)

Intersection ID: 46810	Main Street: ARBOR_VISTA_DR	Cross Street: CLAUDE_FREEMAN_DR	Location: N
ADA ID: 3803D1316689	Curb Cut Type: MedianRefuge2	Initial Pass/Fail: Fail	Overall Compliance: No
Codes/Mitigation Info/Possible Solution		Field Measurements/Component Compliance	
Severity Score: 0

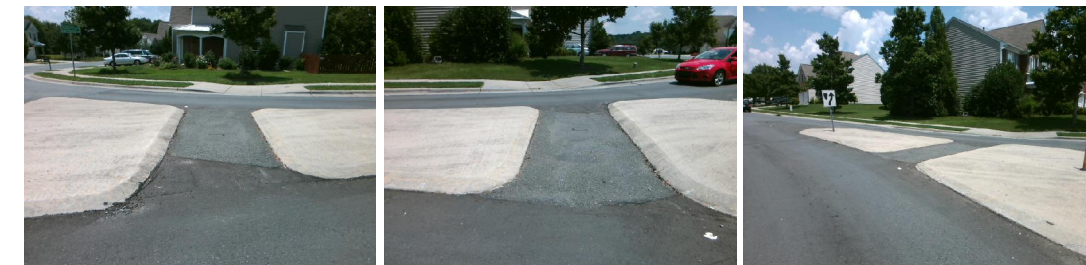
Compliance	Description	Data	Compliance	Description	Data
Yes	Refuge 1 Length (In)	78.0	N/A	Gutter 1 Ponding?	N/A
Yes	Refuge 1 Width (In)	64.0	N/A	Gutter 1 Lip Ht (In)	N/A
Yes	Refuge 1 Slope (%)	0.1	N/A	Gutter 1 Slope (%)	N/A
Yes	Refuge 1 X Slope (%)	3.8	N/A	Gutter 1 X Slope (%)	N/A
N/A	Painted X Walk1?	No	N/A	DWS 1 Provided?	N/A
N/A	X Walk 1 Direction	To E	N/A	DWS 1 Contrast?	N/A
N/A	X Walk 1 Width (In)	N/A	N/A	DWS 1 Length (In)	N/A
N/A	Road 1 Slope (%)	2.2	N/A	DWS 1 Full Width?	N/A
N/A	Road 1 X Slope (%)	2.1	N/A	DWS 1 Offset (In)	N/A
Yes	Refuge 2 Length (In)	78.0	N/A	Gutter 2 Ponding?	N/A
Yes	Refuge 2 Width (In)	64.0	N/A	Gutter 2 Lip Ht (In)	N/A
Yes	Refuge 2 Slope (%)	0.1	N/A	Gutter 2 Slope (%)	N/A
Yes	Refuge 2 X Slope (%)	4.2	N/A	Gutter 2 X Slope (%)	N/A
N/A	Painted X Walk2?	No	N/A	DWS 2 Provided?	N/A
N/A	X Walk 2 Direction	To W	N/A	DWS 2 Contrast?	N/A
N/A	X Walk 2 Width (In)	N/A	N/A	DWS 2 Length (In)	N/A

N/A	Road 2 Slope (%)	5.5	N/A	DWS 2 Full Width?	N/A
N/A	Road 2 X Slope (%)	5.0	N/A	DWS 2 Offset (In)	N/A
N/A	Refuge 3 Length (in)	N/A	N/A	Gutter 3 Ponding?	N/A
N/A	Refuge 3 Width (in)	N/A	N/A	Gutter 3 Lip Ht (in)	N/A
N/A	Refuge 3 Slope (%)	N/A	N/A	Gutter 3 Slope (%)	N/A
N/A	Refuge 3 XSlope (%)	N/A	N/A	Gutter 3 XSlope (%)	N/A
N/A	Painted X Walk3?	No	N/A	DWS 3 Provided?	N/A
N/A	X Walk 3 Direction	N/A	N/A	DWS 3 Contrast?	N/A
N/A	X Walk 3 Width (in)	N/A	N/A	DWS 3 Length (in)	N/A
N/A	Road 3 Slope (%)	N/A	N/A	DWS 3 Full Width?	N/A
N/A	Road 3 XSlope (%)	N/A	N/A	DWS 3 Offset (in)	N/A
Yes	Any Obstructions?	N/A	N/A	Storm Grate/Utility Hazard?	N/A
N/A	Obstruction Type		N/A	Storm Grate/Utility Type	
		N/A			N/A
N/A	Surface Condition	Good

**Remove & Replace Entire Refuge.**
