Access Compliance Report

Public Rights-of-Way

(Island Curb Cuts)

Intersection ID: 42988	Main Street: UNIVERSITY_CITY_BV	Cross Street: UNIVERSITY_WALK_CR	Location:	W
ADA ID: 38FBB0215ACE	Curb Cut Type: MedianRefuge2	Initial Pass/Fail: Fail	Overall Compliance: No	Severity Score: 25
Codes/Mitigation Info/Possible Solution		Field Measurements/Component Compliance

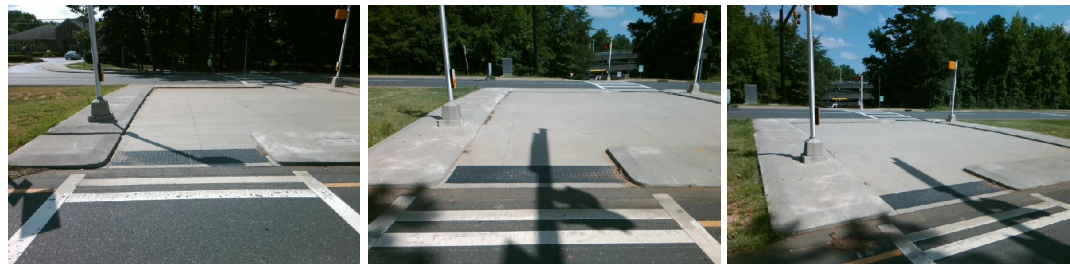
Compliance	Description	Data	Compliance	Description	Data
Yes	Refuge 1 Length (In)	60.0	N/A	Gutter 1 Ponding?	N/A
Yes	Refuge 1 Width (In)	100.0	N/A	Gutter 1 Lip Ht (In)	N/A
No	Refuge 1 Slope (%)	8.5	N/A	Gutter 1 Slope (%)	N/A
Yes	Refuge 1 X Slope (%)	0.3	N/A	Gutter 1 X Slope (%)	N/A
N/A	Painted X Walk1?	Yes	N/A	DWS 1 Provided?	N/A
N/A	X Walk 1 Direction	To SE	N/A	DWS 1 Contrast?	N/A
N/A	X Walk 1 Width (In)	111.0	N/A	DWS 1 Length (In)	N/A
N/A	Road 1 Slope (%)	0.1	N/A	DWS 1 Full Width?	N/A
N/A	Road 1 X Slope (%)	3.0	N/A	DWS 1 Offset (In)	N/A
Yes	Refuge 2 Length (In)	60.0	N/A	Gutter 2 Ponding?	N/A
Yes	Refuge 2 Width (In)	100.0	N/A	Gutter 2 Lip Ht (In)	N/A
Yes	Refuge 2 Slope (%)	0.9	N/A	Gutter 2 Slope (%)	N/A
Yes	Refuge 2 X Slope (%)	0.3	N/A	Gutter 2 X Slope (%)	N/A
N/A	Painted X Walk2?	Yes	N/A	DWS 2 Provided?	N/A
N/A	X Walk 2 Direction	To NW	N/A	DWS 2 Contrast?	N/A
N/A	X Walk 2 Width (In)	112.0	N/A	DWS 2 Length (In)	N/A

N/A	Road 2 Slope (%)	0.7	N/A	DWS 2 Full Width?	N/A
N/A	Road 2 X Slope (%)	1.4	N/A	DWS 2 Offset (In)	N/A
N/A	Refuge 3 Length (in)	N/A	N/A	Gutter 3 Ponding?	N/A
N/A	Refuge 3 Width (in)	N/A	N/A	Gutter 3 Lip Ht (in)	N/A
N/A	Refuge 3 Slope (%)	N/A	N/A	Gutter 3 Slope (%)	N/A
N/A	Refuge 3 XSlope (%)	N/A	N/A	Gutter 3 XSlope (%)	N/A
N/A	Painted X Walk3?	No	N/A	DWS 3 Provided?	N/A
N/A	X Walk 3 Direction	N/A	N/A	DWS 3 Contrast?	N/A
N/A	X Walk 3 Width (in)	N/A	N/A	DWS 3 Length (in)	N/A
N/A	Road 3 Slope (%)	N/A	N/A	DWS 3 Full Width?	N/A
N/A	Road 3 XSlope (%)	N/A	N/A	DWS 3 Offset (in)	N/A
Yes	Any Obstructions?	N/A	N/A	Storm Grate/Utility Hazard?	N/A
N/A	Obstruction Type		N/A	Storm Grate/Utility Type	
		N/A			N/A
N/A	Surface Condition	Good

Possible Solutions:

Remove & Replace Entire Refuge.
