# Access Compliance Report

## Public Rights-of-Way

### (Island Curb Cuts)

Intersection ID: 30548	Main Street: SOUTH_BV	Cross Street: N/A	Location: W
ADA ID: 3956D2D74B53	Curb Cut Type: MedianRefuge2	Initial Pass/Fail: Fail	Overall Compliance: No
Codes/Mitigation Info/Possible Solution		Field Measurements/Component Compliance

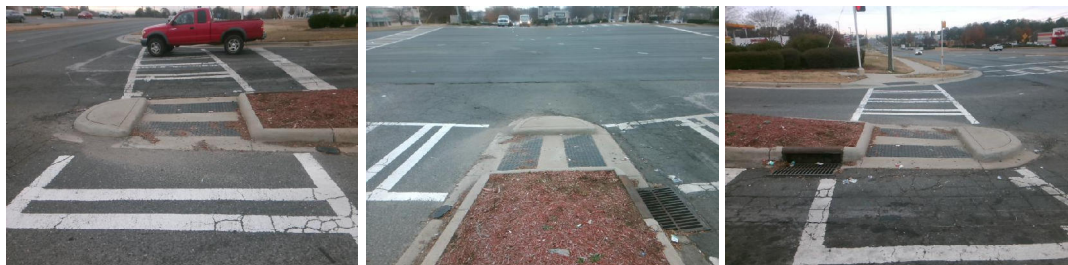
Compliance	Description	Data	Compliance	Description	Data
No	Refuge 1 Length (In)	34.0	N/A	Gutter 1 Ponding?	N/A
Yes	Refuge 1 Width (In)	71.0	N/A	Gutter 1 Lip Ht (In)	N/A
Yes	Refuge 1 Slope (%)	2.7	N/A	Gutter 1 Slope (%)	N/A
No	Refuge 1 X Slope (%)	9.1	N/A	Gutter 1 X Slope (%)	N/A
N/A	Painted X Walk1?	Yes	N/A	DWS 1 Provided?	N/A
N/A	X Walk 1 Direction	To N	N/A	DWS 1 Contrast?	N/A
N/A	X Walk 1 Width (In)	111.0	N/A	DWS 1 Length (In)	N/A
N/A	Road 1 Slope (%)	6.4	N/A	DWS 1 Full Width?	N/A
N/A	Road 1 X Slope (%)	0.8	N/A	DWS 1 Offset (In)	N/A
No	Refuge 2 Length (In)	34.0	N/A	Gutter 2 Ponding?	N/A
Yes	Refuge 2 Width (In)	71.0	N/A	Gutter 2 Lip Ht (In)	N/A
Yes	Refuge 2 Slope (%)	1.5	N/A	Gutter 2 Slope (%)	N/A
No	Refuge 2 X Slope (%)	6.6	N/A	Gutter 2 X Slope (%)	N/A
N/A	Painted X Walk2?	Yes	N/A	DWS 2 Provided?	N/A
N/A	X Walk 2 Direction	To S	N/A	DWS 2 Contrast?	N/A
N/A	X Walk 2 Width (In)	106.0	N/A	DWS 2 Length (In)	N/A

N/A	Road 2 Slope (%)	5.8	N/A	DWS 2 Full Width?	N/A
N/A	Road 2 X Slope (%)	4.7	N/A	DWS 2 Offset (In)	N/A
N/A	Refuge 3 Length (in)	N/A	N/A	Gutter 3 Ponding?	N/A
N/A	Refuge 3 Width (in)	N/A	N/A	Gutter 3 Lip Ht (in)	N/A
N/A	Refuge 3 Slope (%)	N/A	N/A	Gutter 3 Slope (%)	N/A
N/A	Refuge 3 XSlope (%)	N/A	N/A	Gutter 3 XSlope (%)	N/A
N/A	Painted X Walk3?	N/A	N/A	DWS 3 Provided?	N/A
N/A	X Walk 3 Direction	N/A	N/A	DWS 3 Contrast?	N/A
N/A	X Walk 3 Width (in)	N/A	N/A	DWS 3 Length (in)	N/A
N/A	Road 3 Slope (%)	N/A	N/A	DWS 3 Full Width?	N/A
N/A	Road 3 XSlope (%)	N/A	N/A	DWS 3 Offset (in)	N/A
Yes	Any Obstructions?	N/A	N/A	Storm Grate/Utility Hazard?	N/A
N/A	Obstruction Type		N/A	Storm Grate/Utility Type	
		N/A			N/A
N/A	Surface Condition	Good

**Remove & Replace Entire Refuge.**
