Access Compliance Report

Public Rights-of-Way

(Island Curb Cuts)

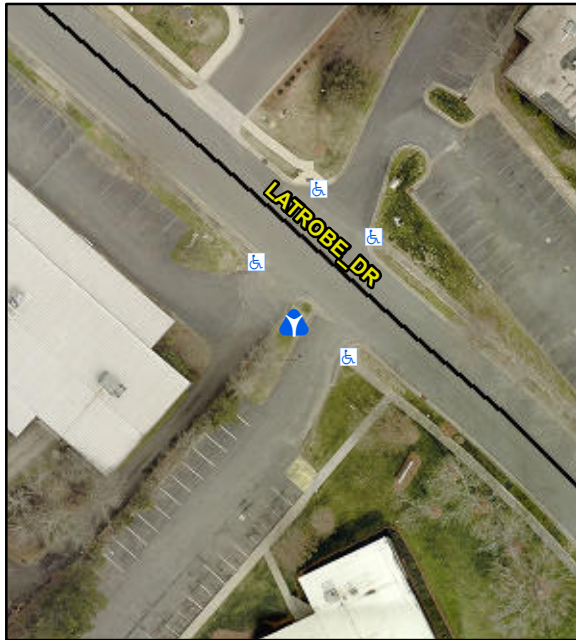
Intersection ID: 10030167	Main Street: LATROBE_DR	Cross Street: N/A	Location: SW
ADA ID: 3958667E23F9	Curb Cut Type: MedianRefuge2	Initial Pass/Fail: Fail	Overall Compliance: No
Codes/Mitigation Info/Possible Solution		Field Measurements/Component Compliance	
Severity Score: 30

Compliance	Description	Data	Compliance	Description	Data
Yes	Refuge 1 Length (In)	49.0	N/A	Gutter 1 Ponding?	N/A
No	Refuge 1 Width (In)	36.0	N/A	Gutter 1 Lip Ht (In)	N/A
Yes	Refuge 1 Slope (%)	1.4	N/A	Gutter 1 Slope (%)	N/A
Yes	Refuge 1 X Slope (%)	0.0	N/A	Gutter 1 X Slope (%)	N/A
N/A	Painted X Walk1?	No	N/A	DWS 1 Provided?	N/A
N/A	X Walk 1 Direction	To SE	N/A	DWS 1 Contrast?	N/A
N/A	X Walk 1 Width (In)	N/A	N/A	DWS 1 Length (In)	N/A
N/A	Road 1 Slope (%)	1.1	N/A	DWS 1 Full Width?	N/A
N/A	Road 1 X Slope (%)	1.4	N/A	DWS 1 Offset (In)	N/A
Yes	Refuge 2 Length (In)	49.0	N/A	Gutter 2 Ponding?	N/A
No	Refuge 2 Width (In)	36.0	N/A	Gutter 2 Lip Ht (In)	N/A
No	Refuge 2 Slope (%)	6.9	N/A	Gutter 2 Slope (%)	N/A
Yes	Refuge 2 X Slope (%)	1.3	N/A	Gutter 2 X Slope (%)	N/A
N/A	Painted X Walk2?	No	N/A	DWS 2 Provided?	N/A
N/A	X Walk 2 Direction	To NW	N/A	DWS 2 Contrast?	N/A
N/A	X Walk 2 Width (In)	N/A	N/A	DWS 2 Length (In)	N/A

N/A	Road 2 Slope (%)	1.1	N/A	DWS 2 Full Width?	N/A
N/A	Road 2 X Slope (%)	2.7	N/A	DWS 2 Offset (In)	N/A
N/A	Refuge 3 Length (in)	N/A	N/A	Gutter 3 Ponding?	N/A
N/A	Refuge 3 Width (in)	N/A	N/A	Gutter 3 Lip Ht (in)	N/A
N/A	Refuge 3 Slope (%)	N/A	N/A	Gutter 3 Slope (%)	N/A
N/A	Refuge 3 XSlope (%)	N/A	N/A	Gutter 3 XSlope (%)	N/A
N/A	Painted X Walk3?	N/A	N/A	DWS 3 Provided?	N/A
N/A	X Walk 3 Direction	N/A	N/A	DWS 3 Contrast?	N/A
N/A	X Walk 3 Width (in)	N/A	N/A	DWS 3 Length (in)	N/A
N/A	Road 3 Slope (%)	N/A	N/A	DWS 3 Full Width?	N/A
N/A	Road 3 XSlope (%)	N/A	N/A	DWS 3 Offset (in)	N/A
Yes	Any Obstructions?	N/A	N/A	Storm Grate/Utility Hazard?	N/A
N/A	Obstruction Type		N/A	Storm Grate/Utility Type	
		N/A			N/A
N/A	Surface Condition	Good

Remove & Replace Entire Refuge.
