Access Compliance Report

Public Rights-of-Way

(Island Curb Cuts)

Intersection ID: 23966	Main Street: CAROLINA_PAVILION_DR_N	Cross Street: SOUTH_BV	Location: E
ADA ID: 3C486D8B95EF	Curb Cut Type: MedianRefuge2	Initial Pass/Fail: Fail	Overall Compliance: No
Severity Score: 1.25			
Codes/Mitigation Info/Possible Solution		Field Measurements/Component Compliance

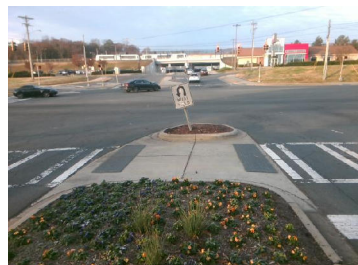
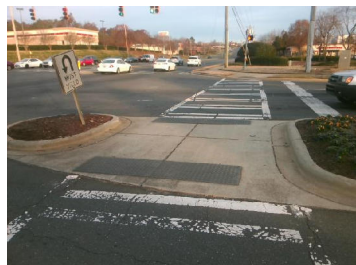
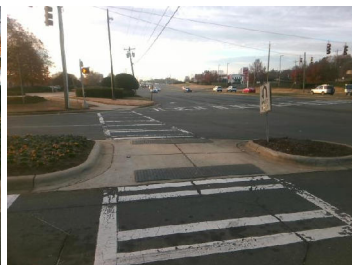
Compliance	Description	Data	Compliance	Description	Data
Yes	Refuge 1 Length (In)	84.5	N/A	Gutter 1 Ponding?	N/A
Yes	Refuge 1 Width (In)	131.0	N/A	Gutter 1 Lip Ht (In)	N/A
Yes	Refuge 1 Slope (%)	1.1	N/A	Gutter 1 Slope (%)	N/A
Yes	Refuge 1 X Slope (%)	2.8	N/A	Gutter 1 X Slope (%)	N/A
N/A	Painted X Walk1?	Yes	N/A	DWS 1 Provided?	N/A
N/A	X Walk 1 Direction	To S	N/A	DWS 1 Contrast?	N/A
N/A	X Walk 1 Width (In)	107.0	N/A	DWS 1 Length (In)	N/A
N/A	Road 1 Slope (%)	2.0	N/A	DWS 1 Full Width?	N/A
N/A	Road 1 X Slope (%)	0.4	N/A	DWS 1 Offset (In)	N/A
Yes	Refuge 2 Length (In)	84.5	N/A	Gutter 2 Ponding?	N/A
Yes	Refuge 2 Width (In)	131.0	N/A	Gutter 2 Lip Ht (In)	N/A
Yes	Refuge 2 Slope (%)	3.0	N/A	Gutter 2 Slope (%)	N/A
Yes	Refuge 2 X Slope (%)	1.9	N/A	Gutter 2 X Slope (%)	N/A
N/A	Painted X Walk2?	Yes	N/A	DWS 2 Provided?	N/A
N/A	X Walk 2 Direction	To N	N/A	DWS 2 Contrast?	N/A
N/A	X Walk 2 Width (In)	108.0	N/A	DWS 2 Length (In)	N/A

N/A	Road 2 Slope (%)	2.9	N/A	DWS 2 Full Width?	N/A
N/A	Road 2 X Slope (%)	0.9	N/A	DWS 2 Offset (In)	N/A
N/A	Refuge 3 Length (in)	N/A	N/A	Gutter 3 Ponding?	N/A
N/A	Refuge 3 Width (in)	N/A	N/A	Gutter 3 Lip Ht (in)	N/A
N/A	Refuge 3 Slope (%)	N/A	N/A	Gutter 3 Slope (%)	N/A
N/A	Refuge 3 XSlope (%)	N/A	N/A	Gutter 3 XSlope (%)	N/A
N/A	Painted X Walk3?	N/A	N/A	DWS 3 Provided?	N/A
N/A	X Walk 3 Direction	N/A	N/A	DWS 3 Contrast?	N/A
N/A	X Walk 3 Width (in)	N/A	N/A	DWS 3 Length (in)	N/A
N/A	Road 3 Slope (%)	N/A	N/A	DWS 3 Full Width?	N/A
N/A	Road 3 XSlope (%)	N/A	N/A	DWS 3 Offset (in)	N/A
Yes	Any Obstructions?	N/A	N/A	Storm Grate/Utility Hazard?	N/A
N/A	Obstruction Type		N/A	Storm Grate/Utility Type	
		N/A			N/A
N/A	Surface Condition	Good

Remove & Replace Entire Refuge.
