Access Compliance Report

Public Rights-of-Way

(Island Curb Cuts)

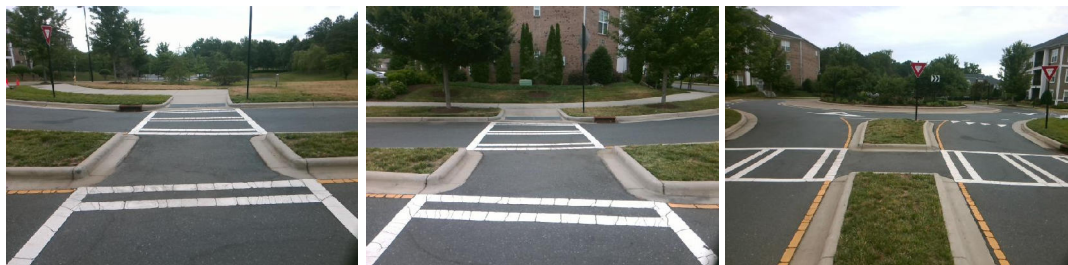
Intersection ID: 52476	Main Street: WHITEHALL_EXECUTIVE_CENTER_DR	Cross Street: CERNY_DR	Location: SE
ADA ID: 3D8C0772709D	Curb Cut Type: MedianRefuge2	Initial Pass/Fail: Fail	Overall Compliance: No
Codes/Mitigation Info/Possible Solution		Field Measurements/Component Compliance

Remove & Replace Entire Refuge.
