# Access Compliance Report

## Public Rights-of-Way

### (Island Curb Cuts)

| Intersection ID: 51704 | Main Street: IKEA_BV | Cross Street: N/A | Location: | N |

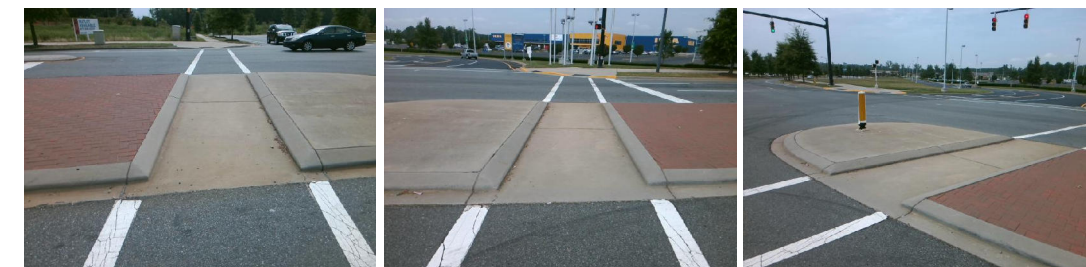
| Compliance | Description | Data | Compliance | Description | Data |
|---|---|---|---|---|---|
| No | Refuge 1 Width (In) | 59.0 | N/A | Gutter 1 Lip Ht (In) | N/A |
| No | Refuge 2 Width (In) | 59.0 | N/A | Gutter 2 Lip Ht (In) | N/A |

**Remove & Replace Entire Refuge.**
