Access Compliance Report

Public Rights-of-Way

(Island Curb Cuts)

Intersection ID: 28003	Main Street: COMMUNITY_HOUSE_RD	Cross Street: WILLOW_ROCK_DR	Location: N
ADA ID: 40FB1F6422DD	Curb Cut Type: MedianRefuge2	Initial Pass/Fail: Pass	Overall Compliance: No
Severity Score: 10			
Codes/Mitigation Info/Possible Solution		Field Measurements/Component Compliance

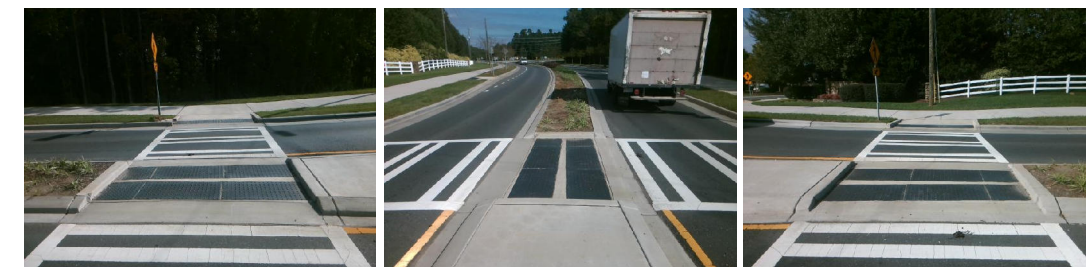
Compliance	Description	Data	Compliance	Description	Data
No	Refuge 1 Length (In)	28.0	Yes	Gutter 1 Ponding?	No
Yes	Refuge 1 Width (In)	118.0	Yes	Gutter 1 Lip Ht (In)	0.0
Yes	Refuge 1 Slope (%)	0.2	No	Gutter 1 Slope (%)	7.5
Yes	Refuge 1 X Slope (%)	0.4	Yes	Gutter 1 X Slope (%)	0.5
N/A	Painted X Walk1?	Yes	No	DWS 1 Provided?	Yes
N/A	X Walk 1 Direction	To E	N/A	DWS 1 Contrast?	Yes
N/A	X Walk 1 Width (In)	108.0	N/A	DWS 1 Length (In)	24.0
N/A	Road 1 Slope (%)	0.3	N/A	DWS 1 Full Width?	Yes
N/A	Road 1 X Slope (%)	3.4	N/A	DWS 1 Offset (In)	1.0
No	Refuge 2 Length (In)	28.0	Yes	Gutter 2 Ponding?	No
Yes	Refuge 2 Width (In)	118.0	Yes	Gutter 2 Lip Ht (In)	0.0
Yes	Refuge 2 Slope (%)	0.3	No	Gutter 2 Slope (%)	7.3
Yes	Refuge 2 X Slope (%)	0.5	Yes	Gutter 2 X Slope (%)	1.9
N/A	Painted X Walk2?	Yes	No	DWS 2 Provided?	Yes
N/A	X Walk 2 Direction	To W	N/A	DWS 2 Contrast?	Yes
N/A	X Walk 2 Width (In)	108.0	N/A	DWS 2 Length (In)	24.0

N/A	Road 2 Slope (%)	0.8	N/A	DWS 2 Full Width?	Yes
N/A	Road 2 X Slope (%)	0.9	N/A	DWS 2 Offset (In)	1.5
N/A	Refuge 3 Length (in)	N/A	N/A	Gutter 3 Ponding?	N/A
N/A	Refuge 3 Width (in)	N/A	N/A	Gutter 3 Lip Ht (in)	N/A
N/A	Refuge 3 Slope (%)	N/A	N/A	Gutter 3 Slope (%)	N/A
N/A	Refuge 3 XSlope (%)	N/A	N/A	Gutter 3 XSlope (%)	N/A
N/A	Painted X Walk3?	N/A	N/A	DWS 3 Provided?	N/A
N/A	X Walk 3 Direction	N/A	N/A	DWS 3 Contrast?	N/A
N/A	X Walk 3 Width (in)	N/A	N/A	DWS 3 Length (in)	N/A
N/A	Road 3 Slope (%)	N/A	N/A	DWS 3 Full Width?	N/A
N/A	Road 3 XSlope (%)	N/A	N/A	DWS 3 Offset (in)	N/A
Yes	Any Obstructions?	N/A	N/A	Storm Grate/Utility Hazard?	No
N/A	Obstruction Type		N/A	Storm Grate/Utility Type	
		N/A			N/A
N/A	Surface Condition	Good

**Remove & Replace Entire Refuge.
Remove & Replace Gutter.**
