Access Compliance Report

Public Rights-of-Way

(Island Curb Cuts)

Intersection ID: 10770	Main Street: ALICE_AV	Cross Street: TUCKASEEGEE_RD	Location: E
ADA ID: 4115AE6F0631	Curb Cut Type: MedianRefuge2	Initial Pass/Fail: Fail	Overall Compliance: No
Severity Score: 1.25			
Codes/Mitigation Info/Possible Solution		Field Measurements/Component Compliance

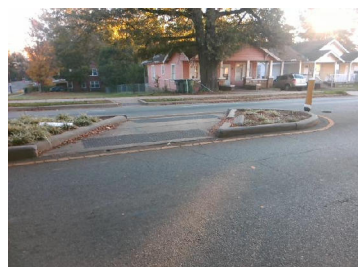
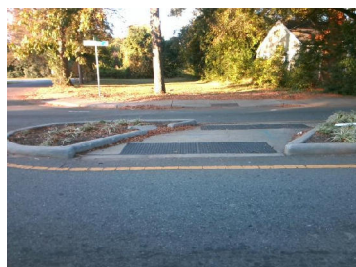
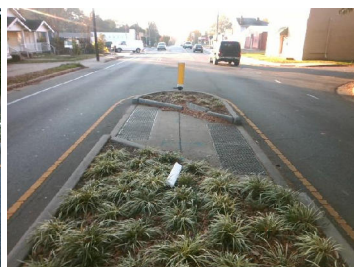
N/A	Road 2 Slope (%)	1.8	N/A	DWS 2 Full Width?	N/A
N/A	Road 2 X Slope (%)	4.1	N/A	DWS 2 Offset (In)	N/A
N/A	Refuge 3 Length (in)	N/A	N/A	Gutter 3 Ponding?	N/A
N/A	Refuge 3 Width (in)	N/A	N/A	Gutter 3 Lip Ht (in)	N/A
N/A	Refuge 3 Slope (%)	N/A	N/A	Gutter 3 Slope (%)	N/A
N/A	Refuge 3 XSlope (%)	N/A	N/A	Gutter 3 XSlope (%)	N/A
N/A	Painted X Walk3?	N/A	N/A	DWS 3 Provided?	N/A
N/A	X Walk 3 Direction	N/A	N/A	DWS 3 Contrast?	N/A
N/A	X Walk 3 Width (in)	N/A	N/A	DWS 3 Length (in)	N/A
N/A	Road 3 Slope (%)	N/A	N/A	DWS 3 Full Width?	N/A
N/A	Road 3 XSlope (%)	N/A	N/A	DWS 3 Offset (in)	N/A
Yes	Any Obstructions?	N/A	N/A	Storm Grate/Utility Hazard?	N/A
N/A	Obstruction Type		N/A	Storm Grate/Utility Type	
		N/A			N/A
N/A	Surface Condition	Good

Possible Solutions:

Remove & Replace Entire Refuge.
