Access Compliance Report

Public Rights-of-Way

(Island Curb Cuts)

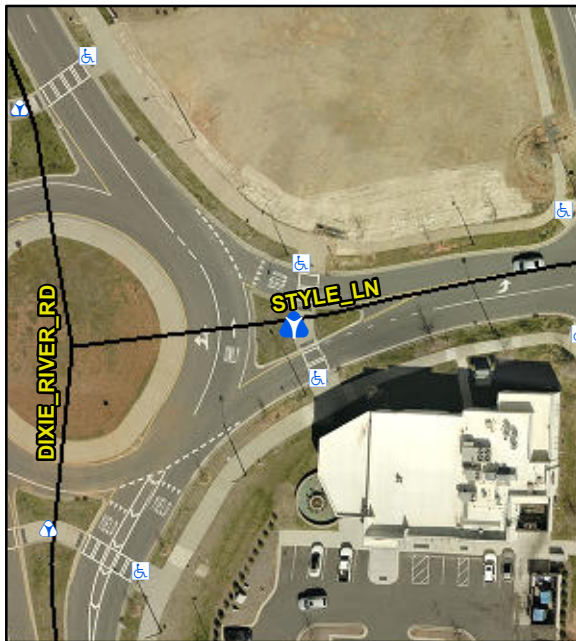
Intersection ID: 53165	Main Street: DIXIE_RIVER_RD	Cross Street: STYLE_LN	Location: E
ADA ID: 417AF7F738B5	Curb Cut Type: MedianRefuge2	Initial Pass/Fail: Fail	Overall Compliance: No
Severity Score: 1.25			
Codes/Mitigation Info/Possible Solution		Field Measurements/Component Compliance

Possible Solutions:

Remove & Replace Entire Refuge.
