Access Compliance Report

Public Rights-of-Way

(Island Curb Cuts)

| Intersection ID: 13985 | Main Street: CAMDEN_RD | Cross Street: EAST_BV | Location: SE |

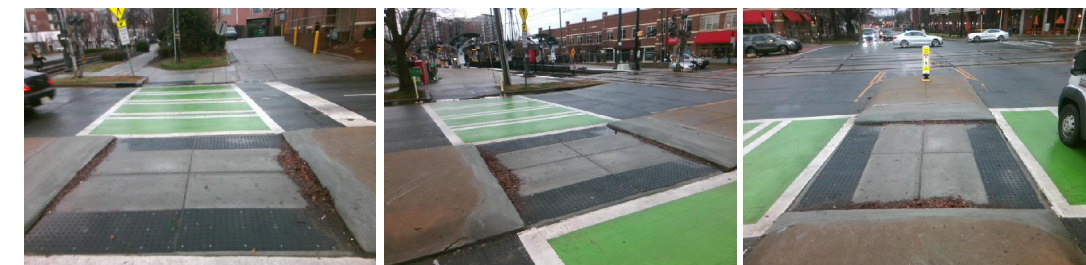
| ADA ID: 41907053C88E | Curb Cut Type: MedianRefuge2 | Initial Pass/Fail: Fail | Overall Compliance: No |

| Compliance | Description | Data | Compliance | Description | Data |
|---|---|---|---|---|---|
| Yes | Refuge 1 X Slope (%) | 2.6 | N/A | Gutter 1 X Slope (%) | N/A |

Possible Solutions:

Remove & Replace Entire Refuge.
