Access Compliance Report

Public Rights-of-Way

(Island Curb Cuts)

Intersection ID: 18963	Main Street: GROVER_RD	Cross Street: SOUTH_BV	Location: S
ADA ID: 42565661D0AE	Curb Cut Type: MedianRefuge2	Initial Pass/Fail: Pass	Overall Compliance: No
Severity Score: 15			
Codes/Mitigation Info/Possible Solution		Field Measurements/Component Compliance

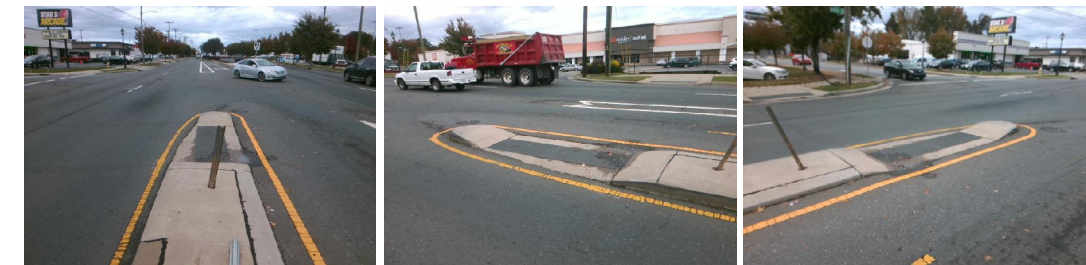
Compliance	Description	Data	Compliance	Description	Data
No	Refuge 1 Length (In)	24.0	Yes	Gutter 1 Ponding?	No
Yes	Refuge 1 Width (In)	96.0	Yes	Gutter 1 Lip Ht (In)	0.0
Yes	Refuge 1 Slope (%)	0.0	Yes	Gutter 1 Slope (%)	3.7
Yes	Refuge 1 X Slope (%)	1.4	Yes	Gutter 1 X Slope (%)	3.5
N/A	Painted X Walk1?	No	No	DWS 1 Provided?	Yes
N/A	X Walk 1 Direction	To W	N/A	DWS 1 Contrast?	Yes
N/A	X Walk 1 Width (In)	N/A	N/A	DWS 1 Length (In)	24.0
N/A	Road 1 Slope (%)	2.8	N/A	DWS 1 Full Width?	Yes
N/A	Road 1 X Slope (%)	4.5	N/A	DWS 1 Offset (In)	12.0
No	Refuge 2 Length (In)	24.0	Yes	Gutter 2 Ponding?	No
Yes	Refuge 2 Width (In)	96.0	Yes	Gutter 2 Lip Ht (In)	0.0
No	Refuge 2 Slope (%)	N/A	Yes	Gutter 2 Slope (%)	3.4
No	Refuge 2 X Slope (%)	N/A	Yes	Gutter 2 X Slope (%)	3.0
N/A	Painted X Walk2?	No	Yes	DWS 2 Provided?	No
N/A	X Walk 2 Direction	To E	N/A	DWS 2 Contrast?	N/A
N/A	X Walk 2 Width (In)	N/A	N/A	DWS 2 Length (In)	N/A
N/A	Road 2 Slope (%)	2.5	N/A	DWS 2 Full Width?	N/A

N/A	Road 2 X Slope (%)	3.0	N/A	DWS 2 Offset (In)	N/A
N/A	Refuge 3 Length (in)	N/A	N/A	Gutter 3 Ponding?	N/A
N/A	Refuge 3 Width (in)	N/A	N/A	Gutter 3 Lip Ht (in)	N/A
N/A	Refuge 3 Slope (%)	N/A	N/A	Gutter 3 Slope (%)	N/A
N/A	Refuge 3 XSlope (%)	N/A	N/A	Gutter 3 XSlope (%)	N/A
N/A	Painted X Walk3?	N/A	N/A	DWS 3 Provided?	N/A
N/A	X Walk 3 Direction	N/A	N/A	DWS 3 Contrast?	N/A
N/A	X Walk 3 Width (in)	N/A	N/A	DWS 3 Length (in)	N/A
N/A	Road 3 Slope (%)	N/A	N/A	DWS 3 Full Width?	N/A
N/A	Road 3 XSlope (%)	N/A	N/A	DWS 3 Offset (in)	N/A
Yes	Any Obstructions?	N/A	N/A	Storm Grate/Utility Hazard?	No
N/A	Obstruction Type		N/A	Storm Grate/Utility Type	
		N/A			N/A
N/A	Surface Condition	Good

Possible Solutions:

Remove & Replace Entire Refuge.
