# Access Compliance Report

## Public Rights-of-Way

### (Island Curb Cuts)

Intersection ID: 10036501	Main Street: ROZZELLES_FERRY_RD	Cross Street: N/A	Location:	N/A
ADA ID: 43EEB23A2A63	Curb Cut Type: MedianRefuge2	Initial Pass/Fail: Fail	Overall Compliance: No	Severity Score: 17.5
Codes/Mitigation Info/Possible Solution		Field Measurements/Component Compliance

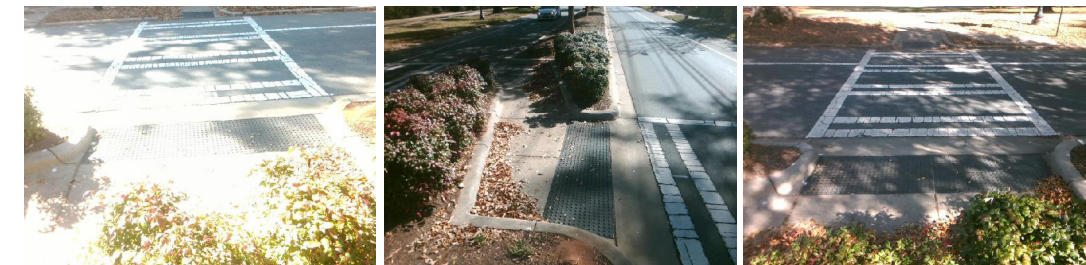
Compliance	Description	Data	Compliance	Description	Data
Yes	Refuge 1 Length (In)	50.0	N/A	Gutter 1 Ponding?	N/A
No	Refuge 1 Width (In)	45.5	N/A	Gutter 1 Lip Ht (In)	N/A
Yes	Refuge 1 Slope (%)	0.8	N/A	Gutter 1 Slope (%)	N/A
Yes	Refuge 1 X Slope (%)	3.3	N/A	Gutter 1 X Slope (%)	N/A
N/A	Painted X Walk1?	Yes	N/A	DWS 1 Provided?	N/A
N/A	X Walk 1 Direction	To E	N/A	DWS 1 Contrast?	N/A
N/A	X Walk 1 Width (In)	110.0	N/A	DWS 1 Length (In)	N/A
N/A	Road 1 Slope (%)	3.0	N/A	DWS 1 Full Width?	N/A
N/A	Road 1 X Slope (%)	1.0	N/A	DWS 1 Offset (In)	N/A
Yes	Refuge 2 Length (In)	50.0	N/A	Gutter 2 Ponding?	N/A
No	Refuge 2 Width (In)	45.5	N/A	Gutter 2 Lip Ht (In)	N/A
Yes	Refuge 2 Slope (%)	1.6	N/A	Gutter 2 Slope (%)	N/A
Yes	Refuge 2 X Slope (%)	2.9	N/A	Gutter 2 X Slope (%)	N/A
N/A	Painted X Walk2?	Yes	N/A	DWS 2 Provided?	N/A
N/A	X Walk 2 Direction	To W	N/A	DWS 2 Contrast?	N/A
N/A	X Walk 2 Width (In)	109.0	N/A	DWS 2 Length (In)	N/A

N/A	Road 2 Slope (%)	2.8	N/A	DWS 2 Full Width?	N/A
N/A	Road 2 X Slope (%)	3.8	N/A	DWS 2 Offset (In)	N/A
N/A	Refuge 3 Length (in)	N/A	N/A	Gutter 3 Ponding?	N/A
N/A	Refuge 3 Width (in)	N/A	N/A	Gutter 3 Lip Ht (in)	N/A
N/A	Refuge 3 Slope (%)	N/A	N/A	Gutter 3 Slope (%)	N/A
N/A	Refuge 3 XSlope (%)	N/A	N/A	Gutter 3 XSlope (%)	N/A
N/A	Painted X Walk3?	N/A	N/A	DWS 3 Provided?	N/A
N/A	X Walk 3 Direction	N/A	N/A	DWS 3 Contrast?	N/A
N/A	X Walk 3 Width (in)	N/A	N/A	DWS 3 Length (in)	N/A
N/A	Road 3 Slope (%)	N/A	N/A	DWS 3 Full Width?	N/A
N/A	Road 3 XSlope (%)	N/A	N/A	DWS 3 Offset (in)	N/A
Yes	Any Obstructions?	N/A	N/A	Storm Grate/Utility Hazard?	N/A
N/A	Obstruction Type		N/A	Storm Grate/Utility Type	
		N/A			N/A
N/A	Surface Condition	Good

**Remove & Replace Entire Refuge.**
