Access Compliance Report

Public Rights-of-Way

(Island Curb Cuts)

Intersection ID: 6149	Main Street: STATESVILLE_RD	Cross Street: SUNTRACE_WY	Location: S
ADA ID: 446AD391FA7D	Curb Cut Type: MedianRefuge2	Initial Pass/Fail: Pass	Overall Compliance: No
Codes/Mitigation Info/Possible Solution		Field Measurements/Component Compliance	
Severity Score: 0.25

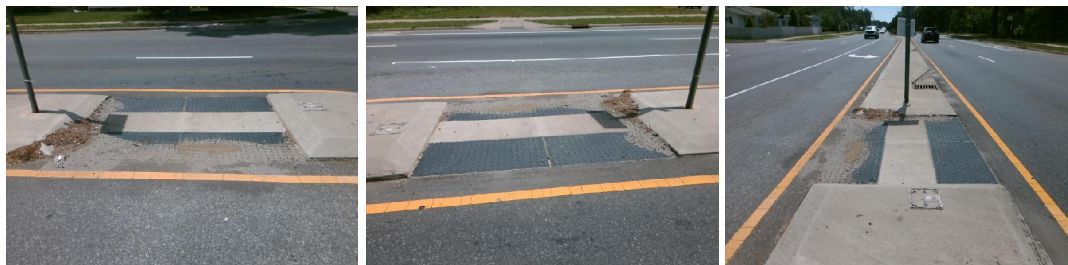
Compliance	Description	Data	Compliance	Description	Data
Yes	Refuge 1 Length (In)	36.0	Yes	Gutter 1 Ponding?	No
Yes	Refuge 1 Width (In)	96.0	No	Gutter 1 Lip Ht (In)	0.25
Yes	Refuge 1 Slope (%)	1.7	Yes	Gutter 1 Slope (%)	0.1
Yes	Refuge 1 X Slope (%)	0.8	Yes	Gutter 1 X Slope (%)	0.7
N/A	Painted X Walk1?	No	Yes	DWS 1 Provided?	Yes
N/A	X Walk 1 Direction	To W	Yes	DWS 1 Contrast?	Yes
N/A	X Walk 1 Width (In)	N/A	Yes	DWS 1 Length (In)	24.0
N/A	Road 1 Slope (%)	0.7	Yes	DWS 1 Full Width?	Yes
N/A	Road 1 X Slope (%)	0.1	Yes	DWS 1 Offset (In)	0.0
Yes	Refuge 2 Length (In)	36.0	Yes	Gutter 2 Ponding?	No
Yes	Refuge 2 Width (In)	96.0	Yes	Gutter 2 Lip Ht (In)	0.0
Yes	Refuge 2 Slope (%)	2.6	Yes	Gutter 2 Slope (%)	1.0
Yes	Refuge 2 X Slope (%)	0.2	Yes	Gutter 2 X Slope (%)	0.4
N/A	Painted X Walk2?	No	Yes	DWS 2 Provided?	Yes
N/A	X Walk 2 Direction	To E	Yes	DWS 2 Contrast?	Yes
N/A	X Walk 2 Width (In)	N/A	Yes	DWS 2 Length (In)	24.0

Grind Gutter Lip.
