Access Compliance Report

Public Rights-of-Way

(Island Curb Cuts)

Intersection ID: 44555	Main Street: UNIVERSITY_CITY_BV	Cross Street: N_TRYON_ST	Location: S
ADA ID: 44A5967BFFB3	Curb Cut Type: MedianRefuge2	Initial Pass/Fail: Pass	Overall Compliance: No Severity Score: 0.25

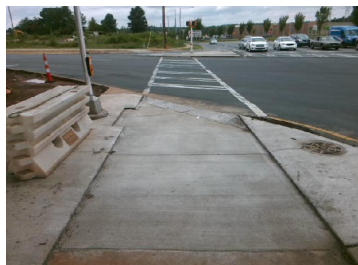
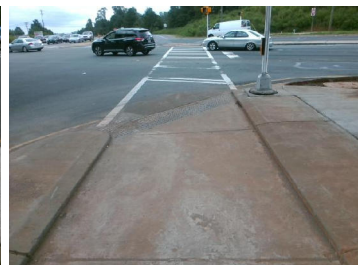
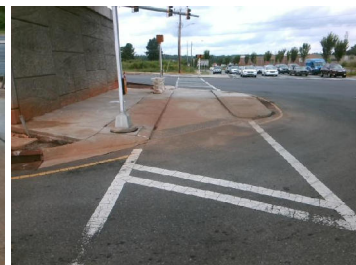
Possible Solutions:		Compliance	Description	Data	
	Grind Gutter Lip.		Yes	Refuge 1 Length (In)	164.0	No
			Yes	Refuge 1 Width (In)	95.0	No
			Yes	Refuge 1 Slope (%)	4.3	Yes
			Yes	Refuge 1 X Slope (%)	1.6	Yes
			N/A	Painted X Walk1?	Yes	Yes
			N/A	X Walk 1 Direction	To W	Yes
			N/A	X Walk 1 Width (In)	124.0	Yes
			N/A	Road 1 Slope (%)	1.5	Yes
			N/A	Road 1 X Slope (%)	1.5	Yes
<p>Surveyor Notes:</p> <p>N/A</p>			Yes	Refuge 2 Length (In)	235.0	No
			Yes	Refuge 2 Width (In)	95.0	No
			Yes	Refuge 2 Slope (%)	0.3	Yes
			Yes	Refuge 2 X Slope (%)	0.6	Yes
			N/A	Painted X Walk2?	Yes	Yes
			N/A	X Walk 2 Direction	To E	Yes
			N/A	X Walk 2 Width (In)	108.0	Yes
			N/A	Road 2 Slope (%)	1.0	Yes
			N/A	Road 2 X Slope (%)	0.1	Yes
			N/A	Refuge 3 Length (in)	N/A	N/A
<p>PROW/ADA:</p> <p>N/A</p>			N/A	Refuge 3 Width (in)	N/A	N/A
			N/A	Refuge 3 Slope (%)	N/A	N/A
