# Access Compliance Report

## Public Rights-of-Way

### (Island Curb Cuts)

| Intersection ID: 17513 | Main Street: PROVIDENCE_DR | Cross Street: PROVIDENCE_RD | Location: SE |

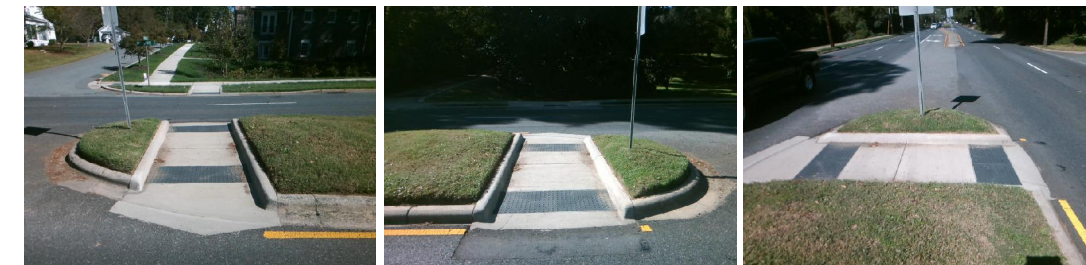
| Compliance | Description | Data | Compliance | Description | Data |
|---|---|---|---|---|---|
| No | Refuge 1 Width (In) | 59.0 | N/A | Gutter 1 Lip Ht (In) | N/A |
| No | Refuge 1 X Slope (%) | 5.2 | N/A | Gutter 1 X Slope (%) | N/A |
| No | Refuge 2 Width (In) | 59.0 | N/A | Gutter 2 Lip Ht (In) | N/A |

**Remove & Replace Entire Refuge.**
